River Trym and Hazel Brook, North Bristol

Wild Trout Trust report following an Advisory Visit, January 2019

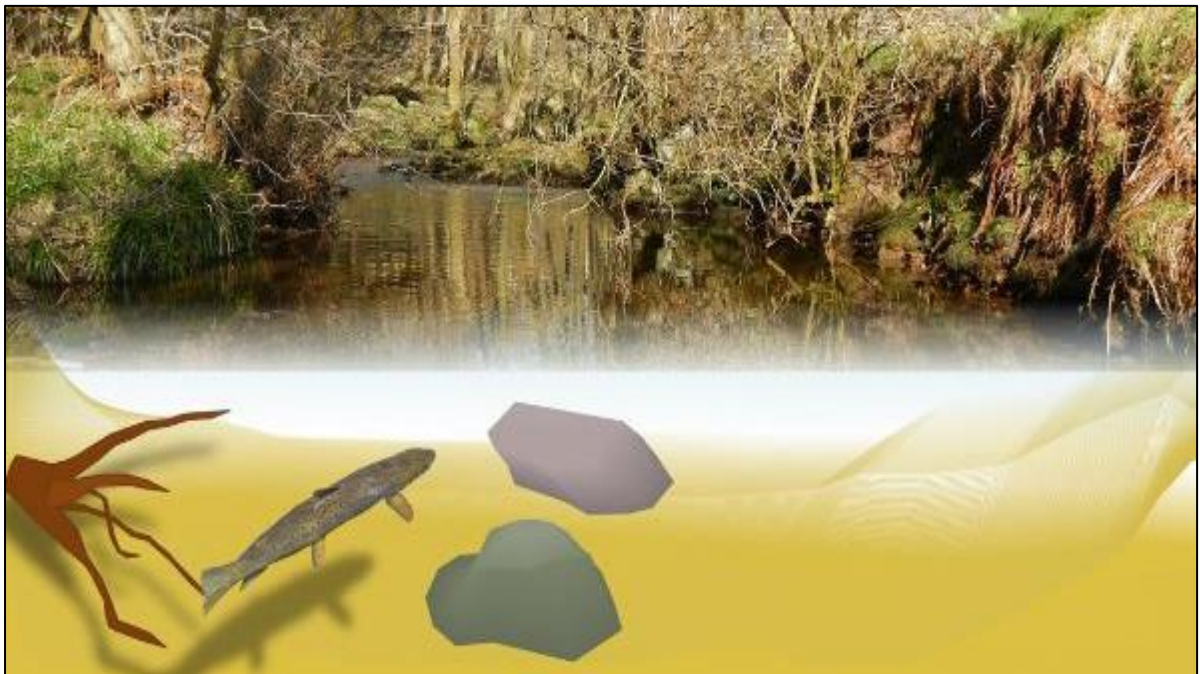
Figure 5: The availability of deeper water (>30cm) bolt holes, low overhanging cover and/or larger submerged structures such as boulders, fallen trees, large root-wads etc. provide ideal adult trout habitat.

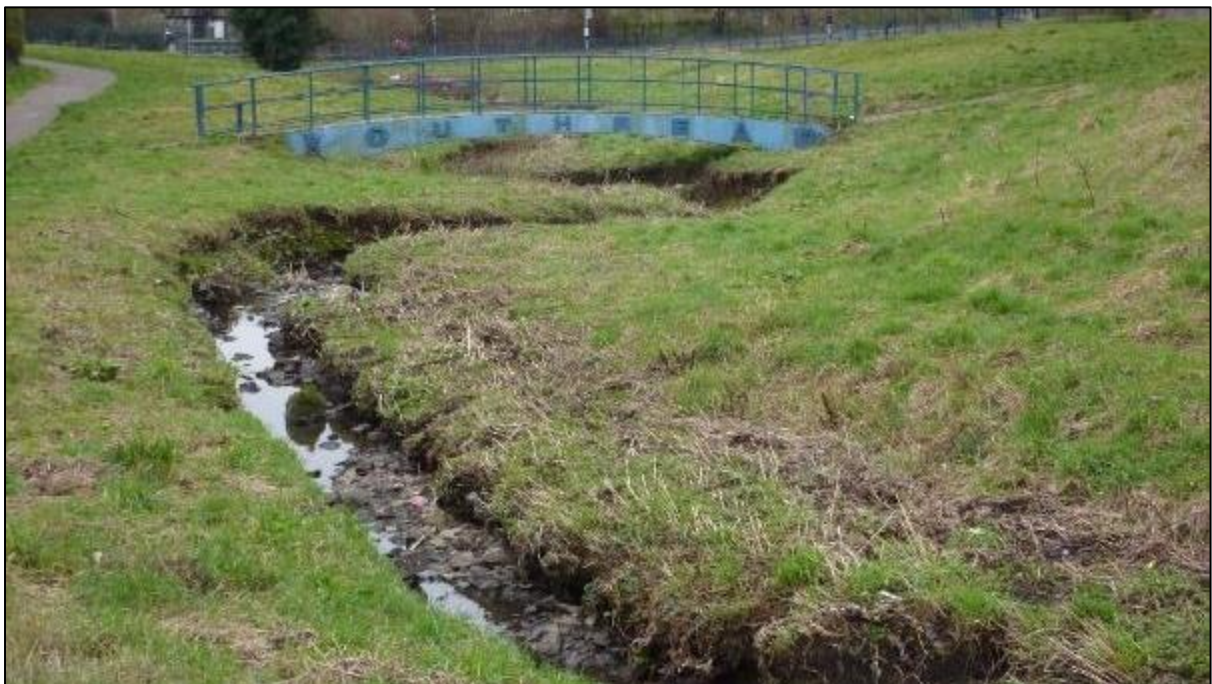
Somewhat unusually in such an urban area, significant stretches of the channel appeared to meander naturally through the contours of the green space – suggesting that the stream was only partially straightened from its original course, while intensive 20th century residential development took place all around (Figure. 6).

Figure 6: Scoured but still sinuous: the upper River Trym in Southmead

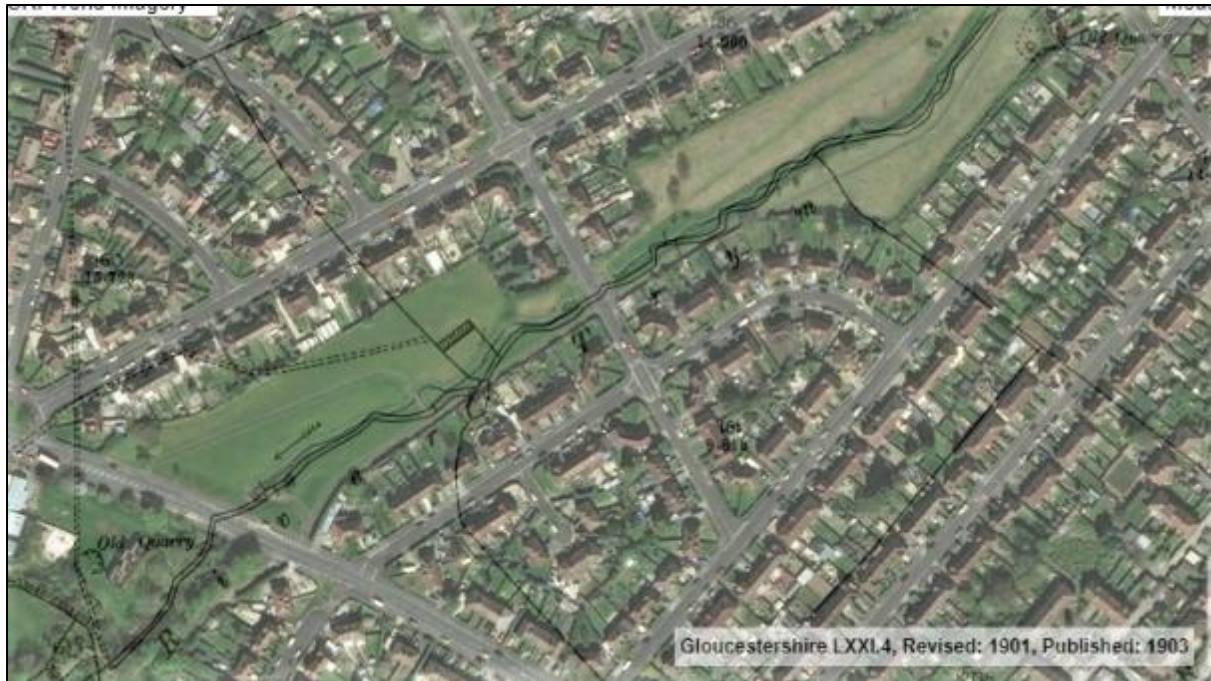
This is confirmed by laying modern satellite imagery over early 20th century maps (OS 25 inch: 1892 – 1914): the channel now lacks some of its sharper meanders, but still appears to retain the general course of an upland limestone stream (Figure 7).

Figure 7: Laying modern satellite imagery over an early 20th century map enables comparison of the historic and contemporary courses of the River Trym through the Southmead green space (Mapping via National Library of Scotland)

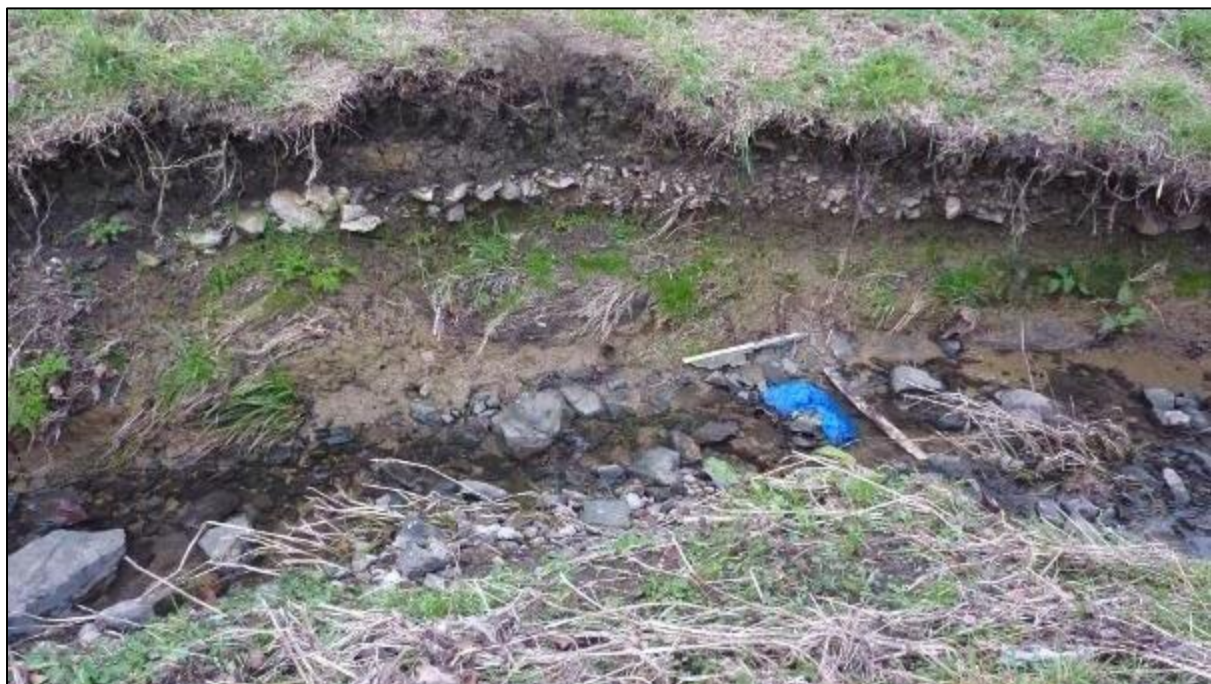
On the ground, however, a wide range of other urban impacts was evident (Figure 8). Although base flows were minimal (a frequent indicator of an unnaturally flashy catchment), the predominant profile of the banks (even on the inside of bends) was vertical and eroding, rather than shallow and gradually shelving – suggesting that the channel is subject to dramatic fluctuations in flow.

Figure 8: Very low base flows expose unsorted gravel and cobbles in the upper Trym. Sorting could be improved by introducing Large Woody Material: further gravel will be supplied by more controlled erosion from seams in the banks.

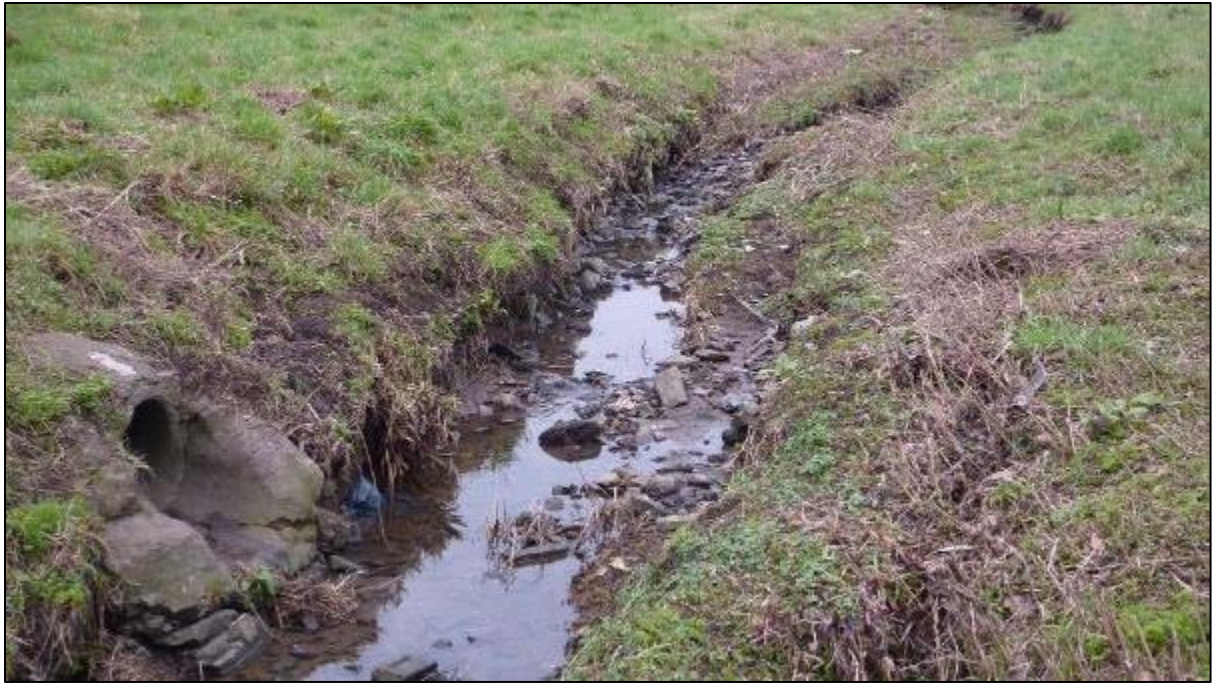
At several points along the course of the stream through the green space (and indeed all down the river), surface water outfalls were observed (Figure 9). These would have been installed to carry rainwater from surrounding residential areas into the river, but over time it is likely that many have been mistakenly 'misconnected' to pipes from kitchens and bathrooms - leading to some of the sewage litter which was apparent on structures like the trash screen at the lower end of the green space (and indeed to one of the reasons why the Trym is failing its WFD target). Tracing the source of misconnections is a time-consuming task for water companies, but it can make a very tangible difference to the chemical and biological health of such a small urban stream.

Figure 9: Bare, eroded and slumping banks suggest invasion by Himalayan balsam. Also note the surface water pipe on the left-hand side of this photo: almost certainly a source of water quality issues for the Trym.

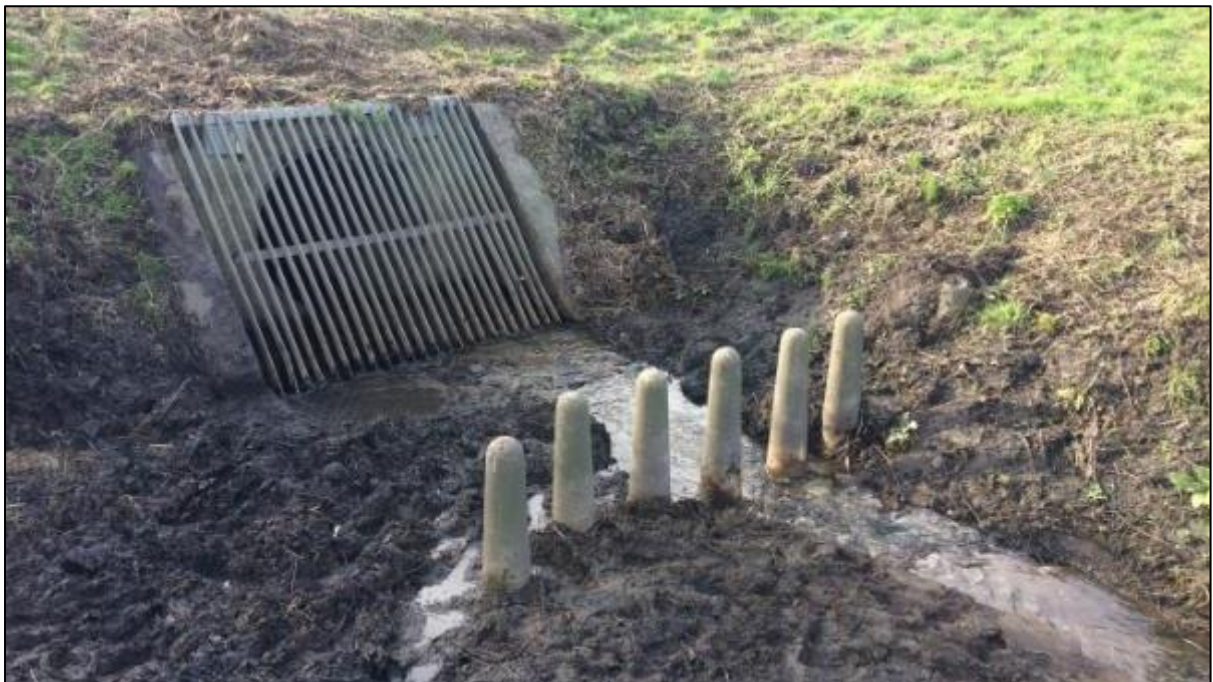
At Trowbridge Road (ST 58480 78093) and again at Doncaster Road (ST 58316 77985), the natural flow of the river is interrupted by culverts (e.g. Figure 10). Both structures will present impassable obstacles to all species of fish, including European eels (*Anguilla anguilla*) which are globally threatened.

Figure 10: The trash screen over the deep culvert at the lower end of the Southmead green space, after clearance by SusWoT volunteers. The line of concrete bollards was probably installed to stop larger items of fly tipping and other urban debris from blocking the screen after being swept downstream by high runoff. (Photo: SusWoT)

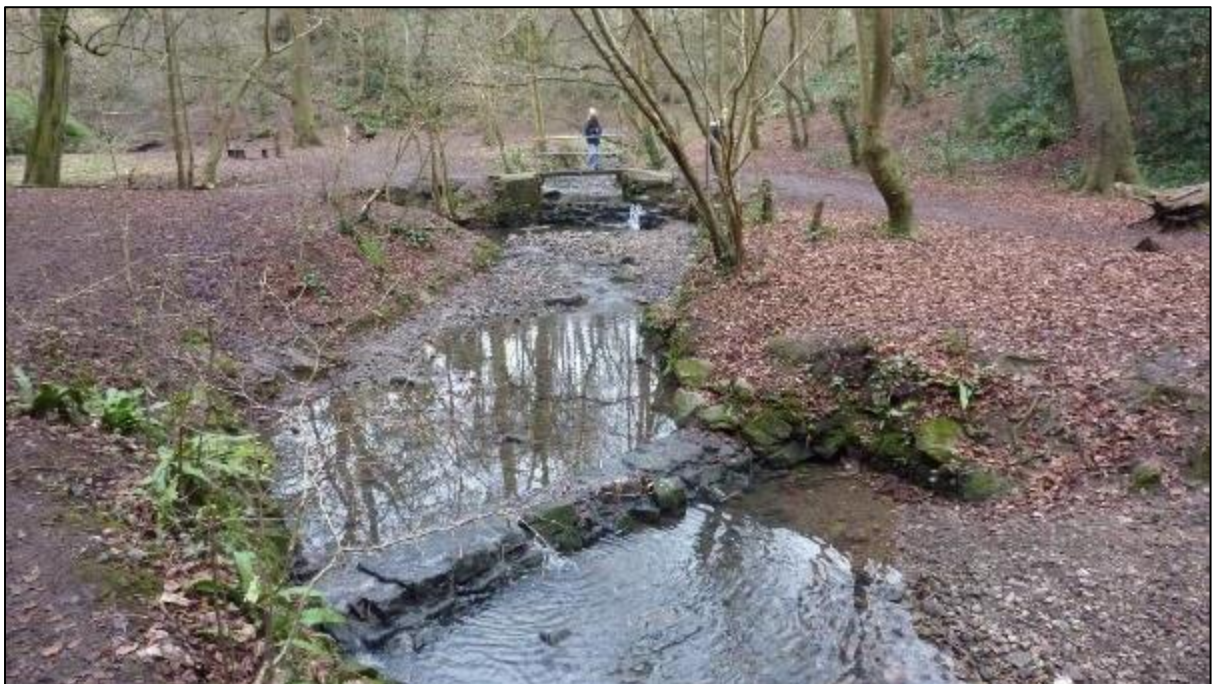
Figure 11: Two of the weirs in Badock's Wood. Possibly installed to 'keep water in the river' in this area of natural sinkholes, they are now doing more ecological harm than good. Removing the weirs and introducing natural woody features would create a healthier and more varied channel structure.

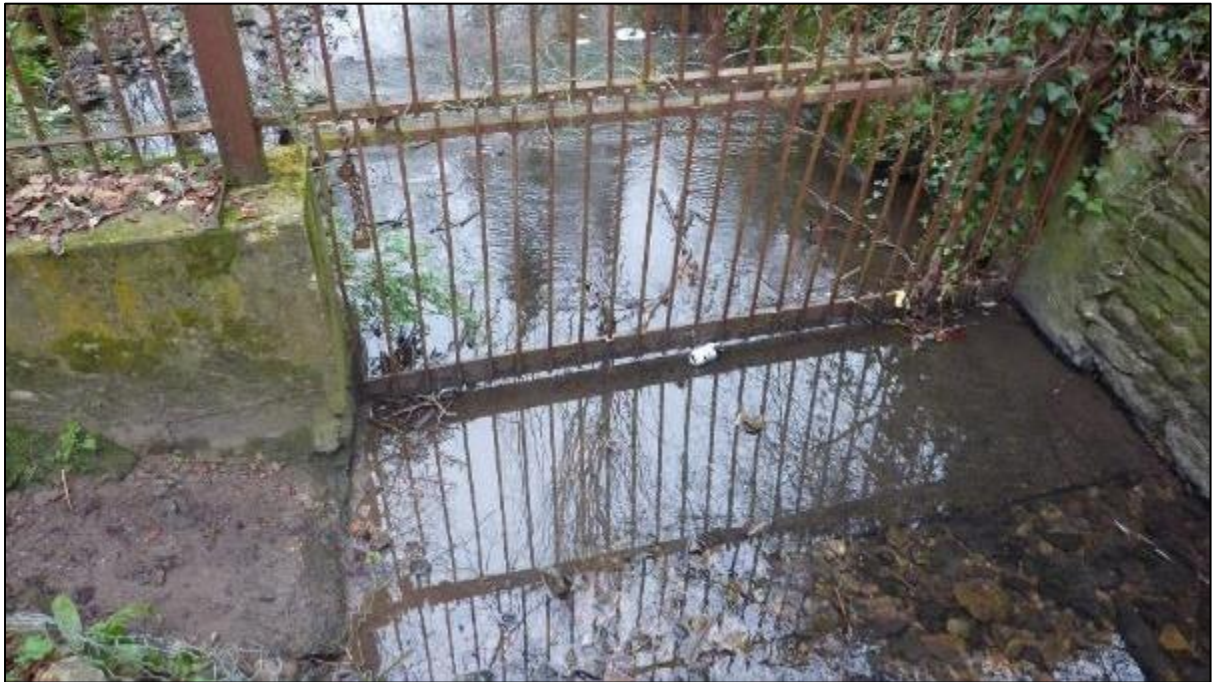
Between Badock's Wood and the private woodland below, a high metal fence extends the full width of the valley, crossing the river with a gate set a short height above a concrete sill (Figure 14). With a shallow laminar flow of water spread across its width, this structure is likely to be a further obstruction to fish passage for all species and age classes.

Figure 14: Water gate between Badock's Wood and private land. Removing the concrete sill would restore fish passage and downstream sediment movement at this point.

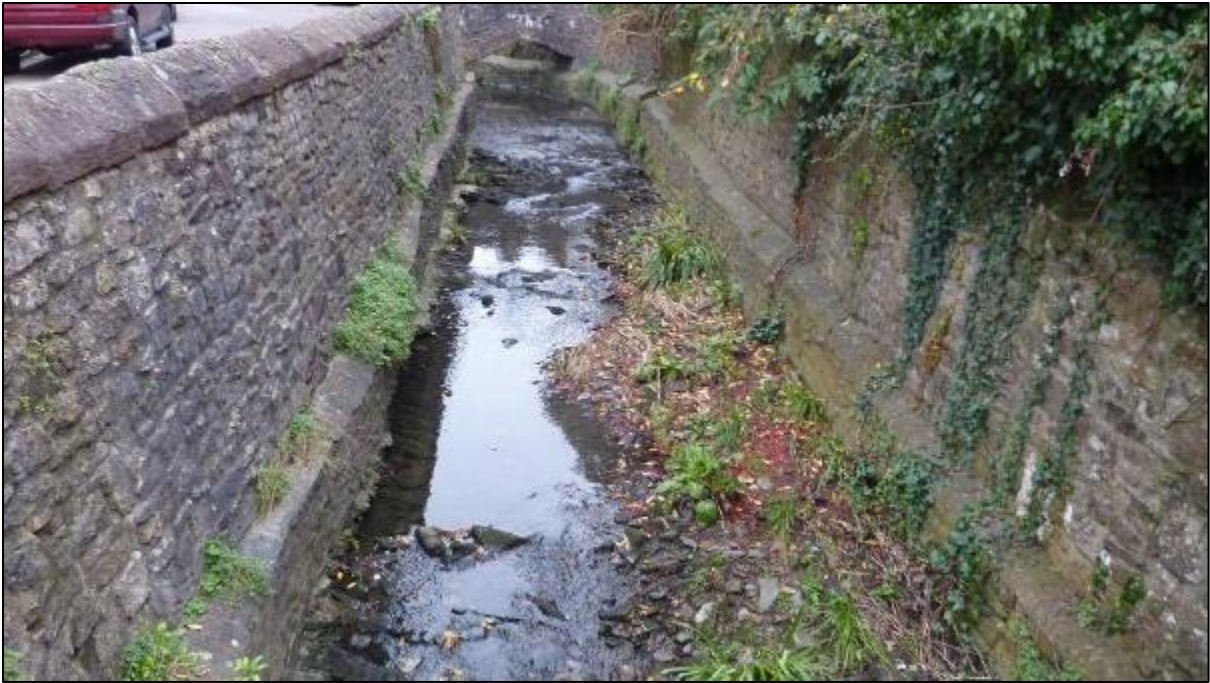
As it flows through the historic village centre of Westbury-on-Trym, the river is alternately fully culverted and enclosed between high retaining walls (Figure 15). For much of this length the river bed has been simplified and armoured with poured concrete or 'crazy paving' slabs – offering very little habitat for fish, invertebrates or any other aquatic life.

In one or two areas, however, bedrock emerges as natural outcrops. These have been colonised by sedges and other emergent plants, and the stream appears to flow at a more natural width and depth, exhibiting sequences of pools and riffles, and providing a healthy mosaic of habitats for different species.

Figure 15: Some stretches of the Trym through Westbury still retain a reasonably natural morphology considering its constrained nature.

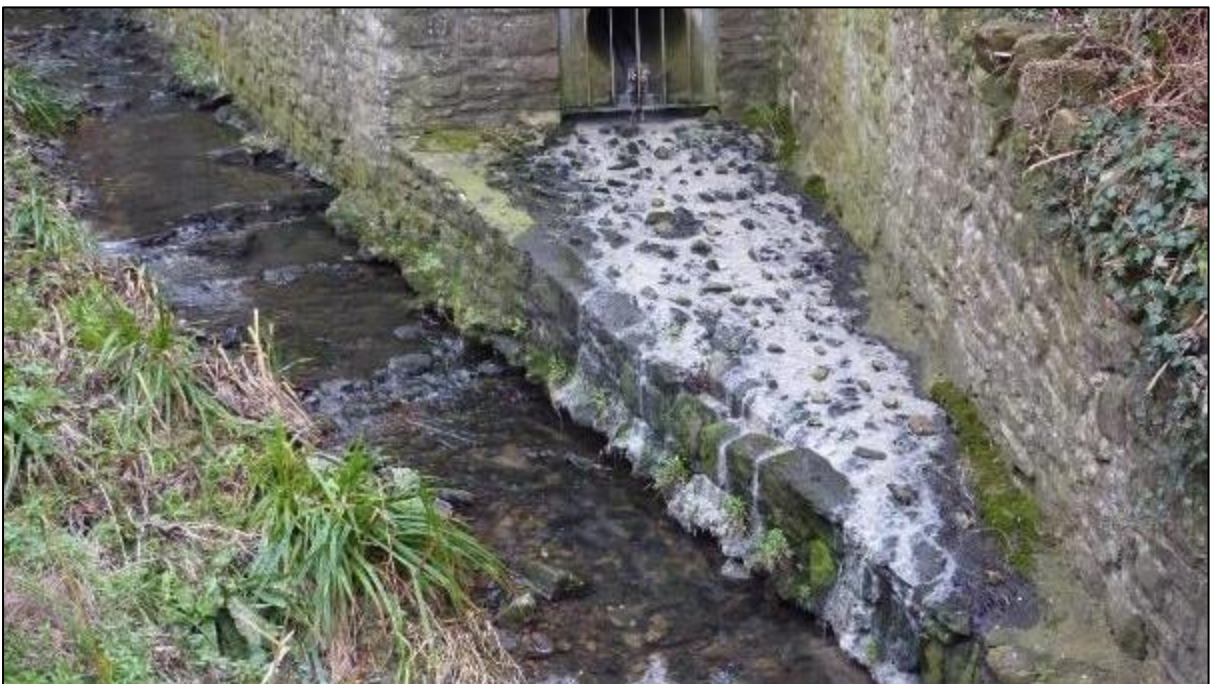
Adjacent to the junction of Trym Road and Channels Hill at ST 57472 77451, a large culvert enters the river from the LB (Figure 16). At the time of this visit, the culvert was constantly discharging a milky liquid onto sewage fungus (colonies of tightly-sheathed filamentous bacteria), suggesting a long-term, severe misconnection problem. This was reported to the Environment Agency's pollution hotline as soon as possible, and it would be wise to maintain a watching brief on this clear source of water quality problems for the river.

Figure 16: A serious misconnection problem in Westbury.

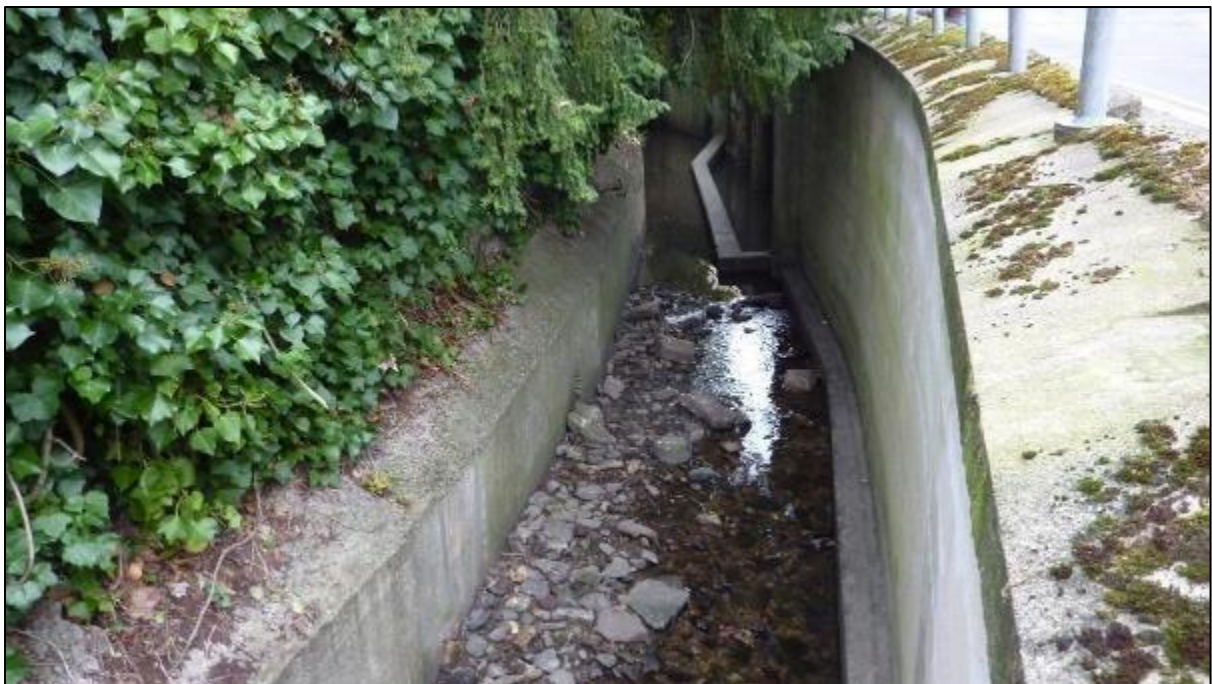
Figure 17: The throttled offtake to Westbury's large underground flood defence scheme.

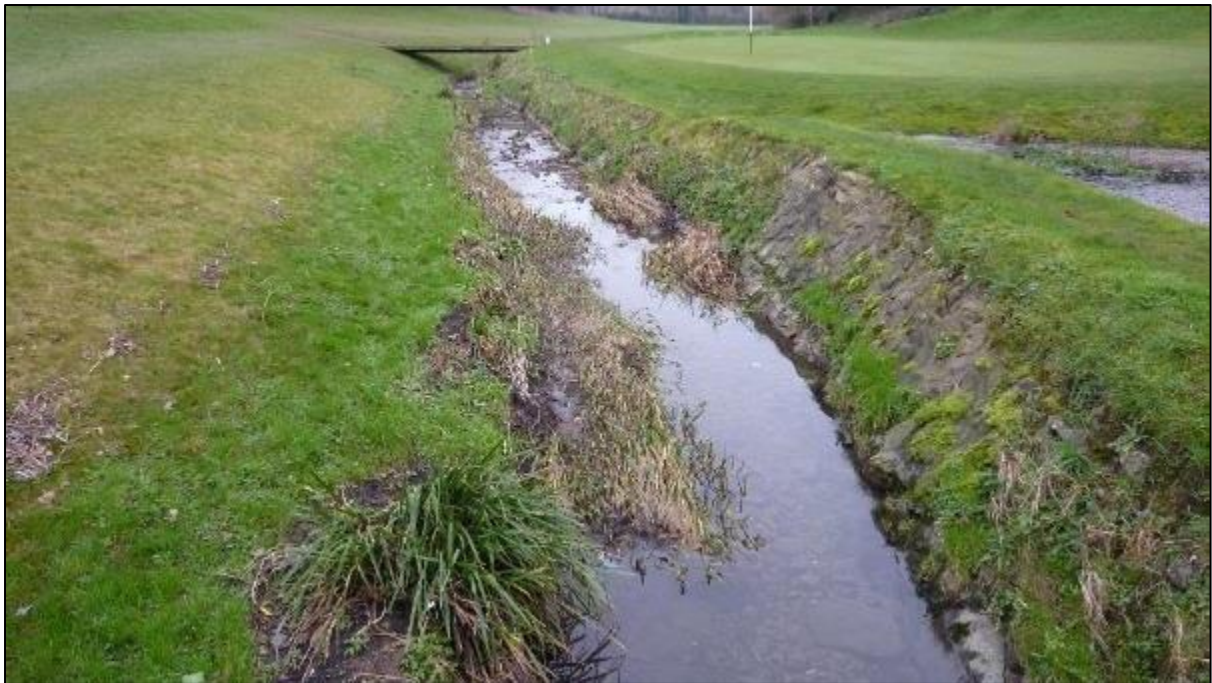
Figure 18: Through Henbury golf course, the Trym's channel has been partly softened with coir rolls on the RB.

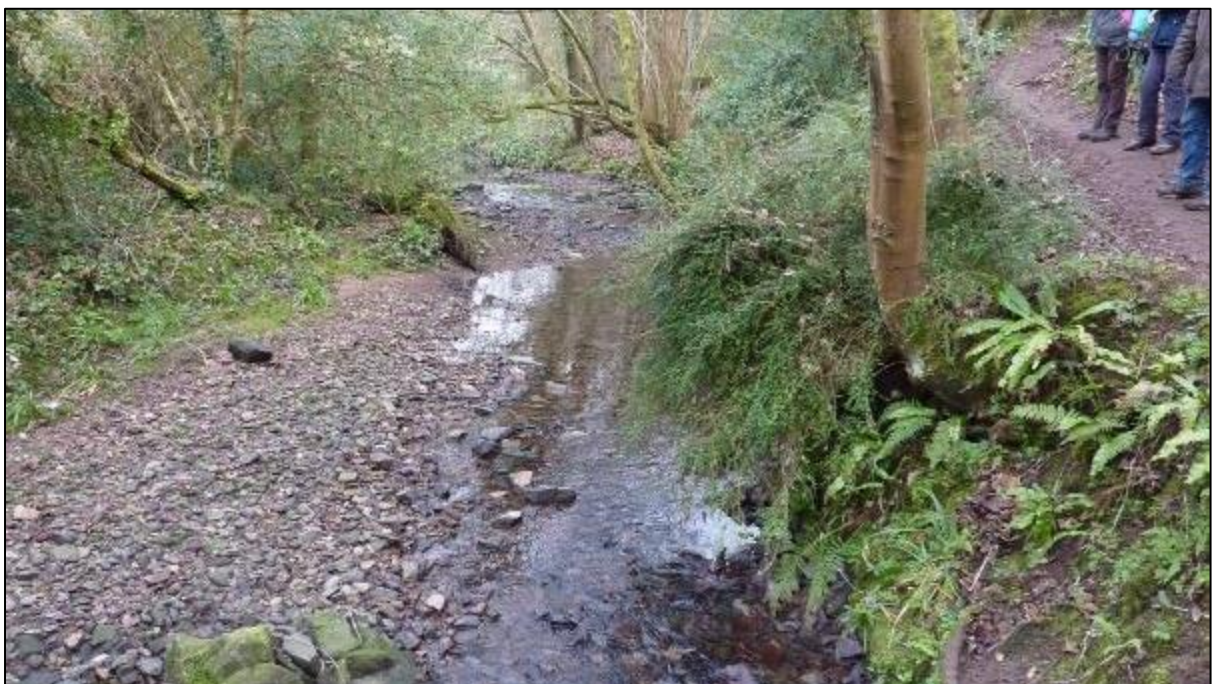
From the edge of the golf course to its confluence with the Hazel Brook, the Trym flows through a woodland gorge, often well below the level of the public footpath, and exhibits increasingly natural hydromorphology – which may even suggest a 'target condition' for restoring other areas of the stream (Figure 19).

Figure 19: Excellent natural channel morphology on the Trym near its junction with Hazel Brook.

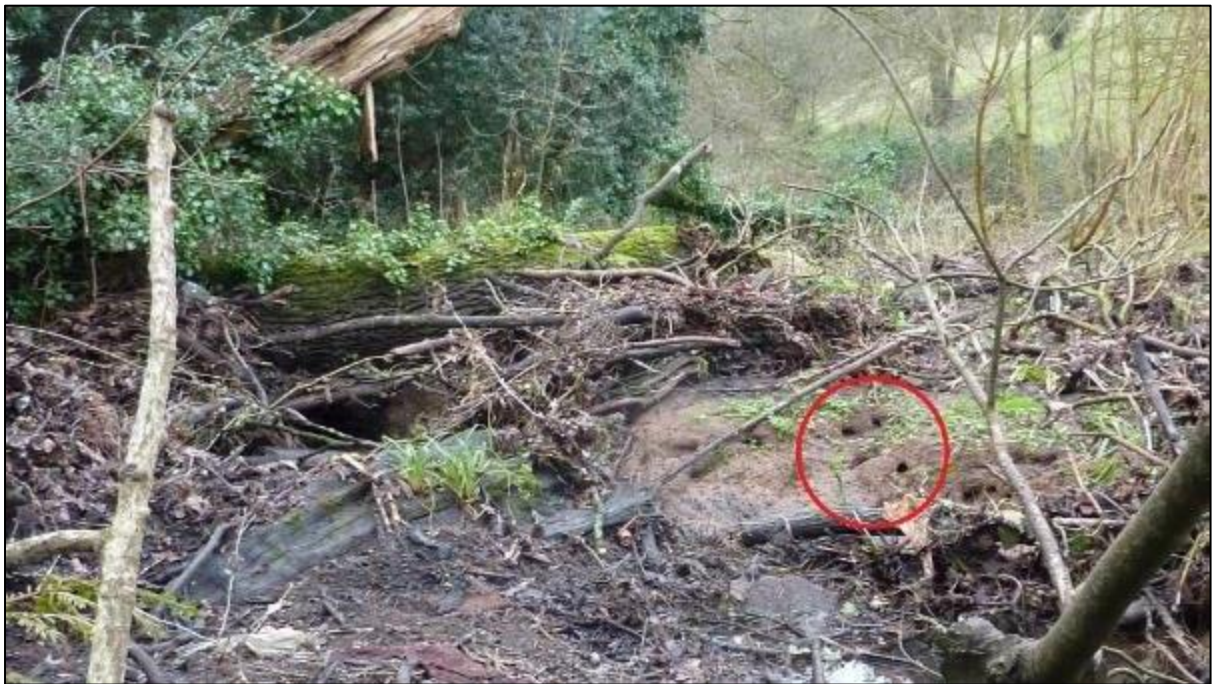
Also noticeable in this area was the effect of a large oak tree which had fallen into the channel and accumulated additional woody material of all sizes (Figure 20). Naturally-formed 'debris dams' like this are very effective for 'slowing the flow', promoting scour to create fish spawning areas, and providing a wide diversity of habitat niches for many species.

Figure 20: Naturally fallen woody habitat features are very important for 'slowing the flow' and generating habitat niches for many species. Note, however, that the cluster of holes circled in red may suggest the presence of American signal crayfish – a problematic INNS which is present throughout much of the Bristol Avon catchment.

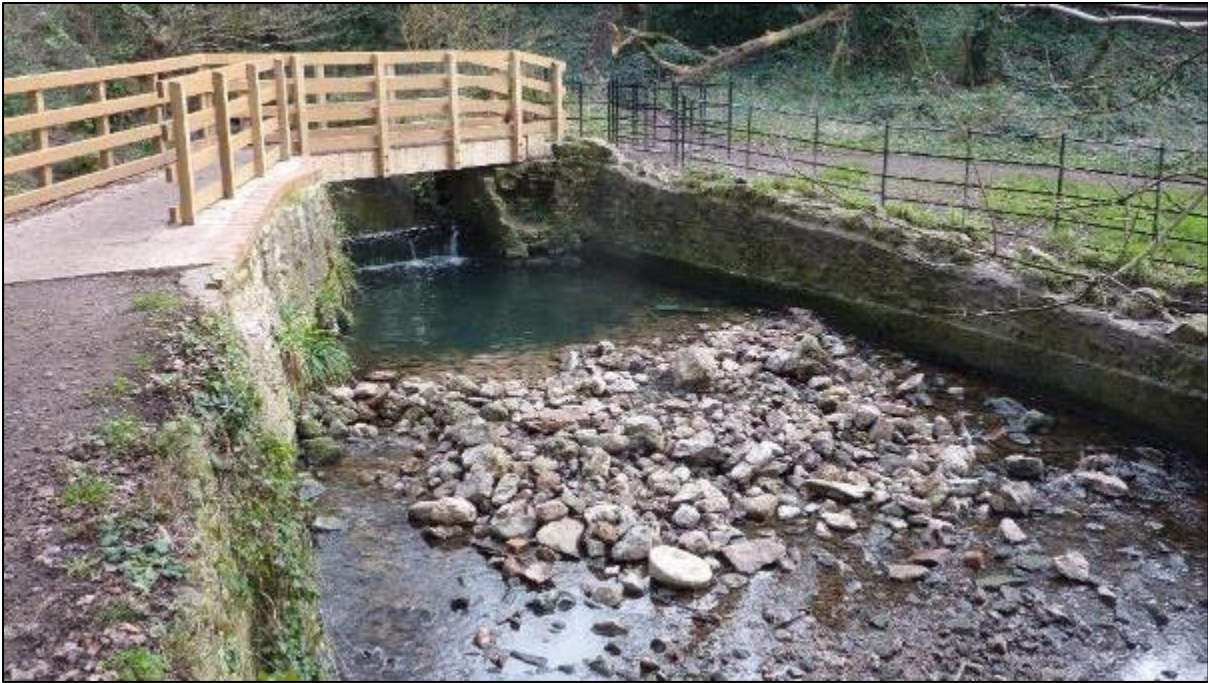
Figure 21: Just before its junction with the Hazel Brook, this weir is a significant barrier to migrating fish.

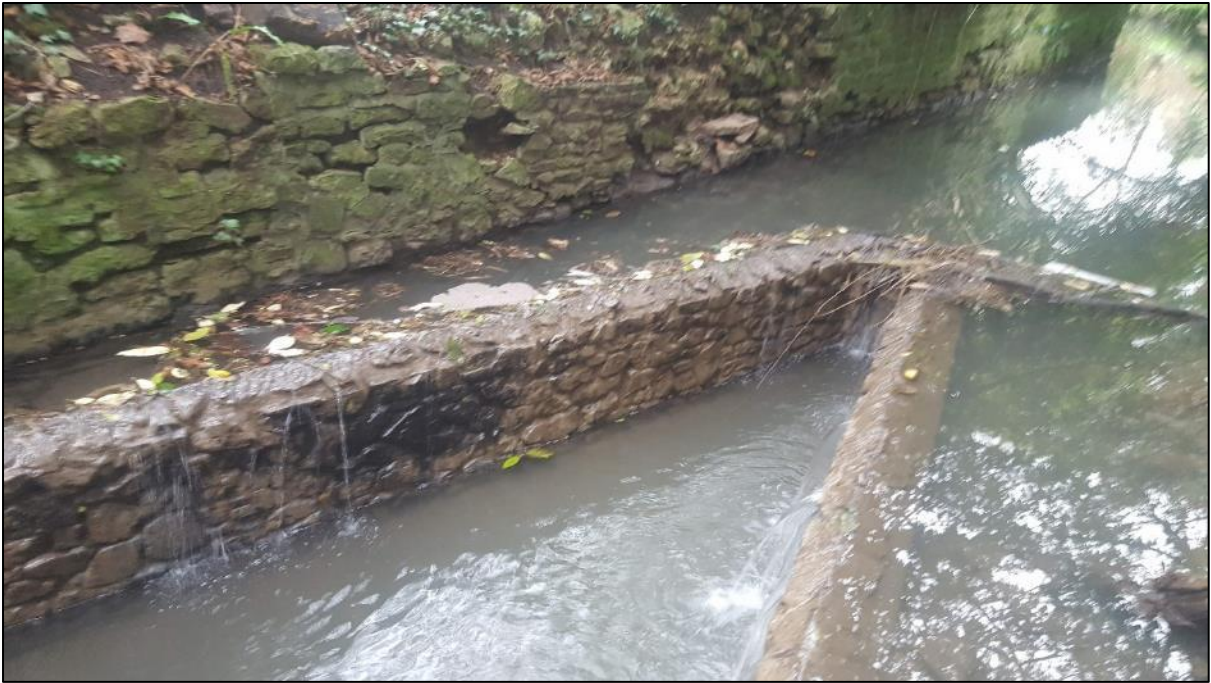
Figure 22: The weir at the upstream extent of the visited section of the Hazel Brook is a barrier to fish passage. The brook shows signs of nutrient enrichment

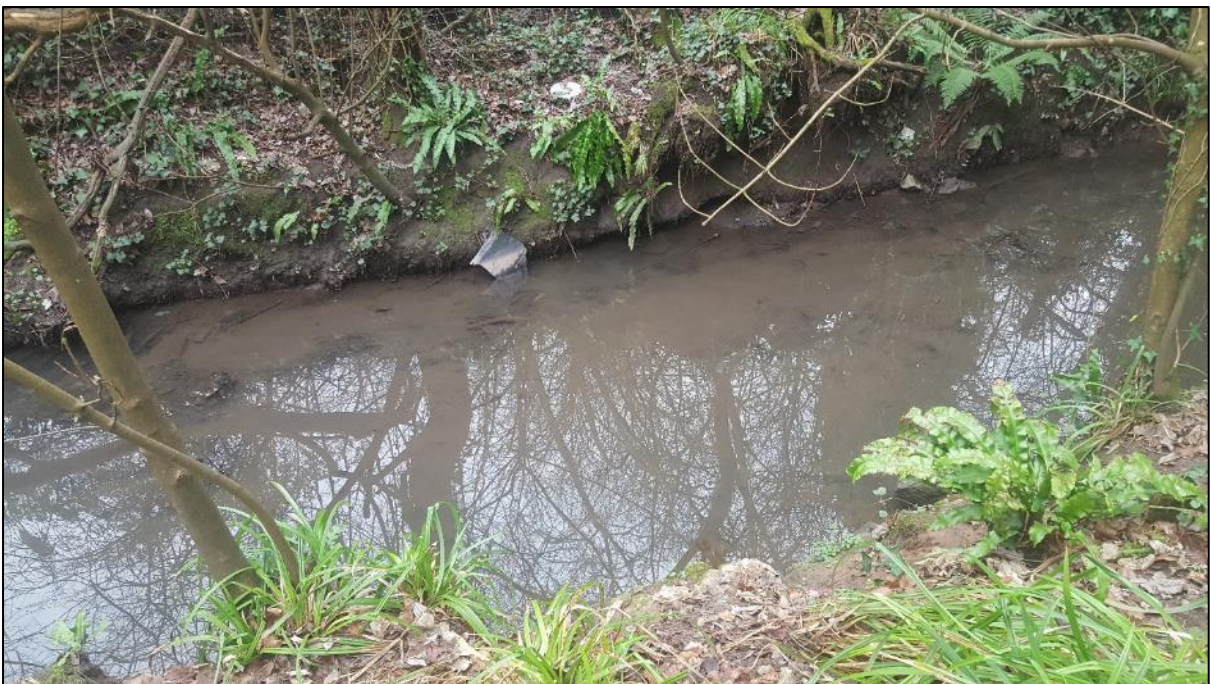
Further signs of catchment run-off problems were observed downstream of the weir as the Hazel Brook flows into the grounds of the Blaise Castle Estate. Fine sediment was observed uniformly smothering the bed through shallower sections (Figure 23), and deeper parts were opaque with the same blueish, milky colouration as observed above the weir (Figure 24).

Figure 23: The bed is smothered in excess fine sediment (silt).

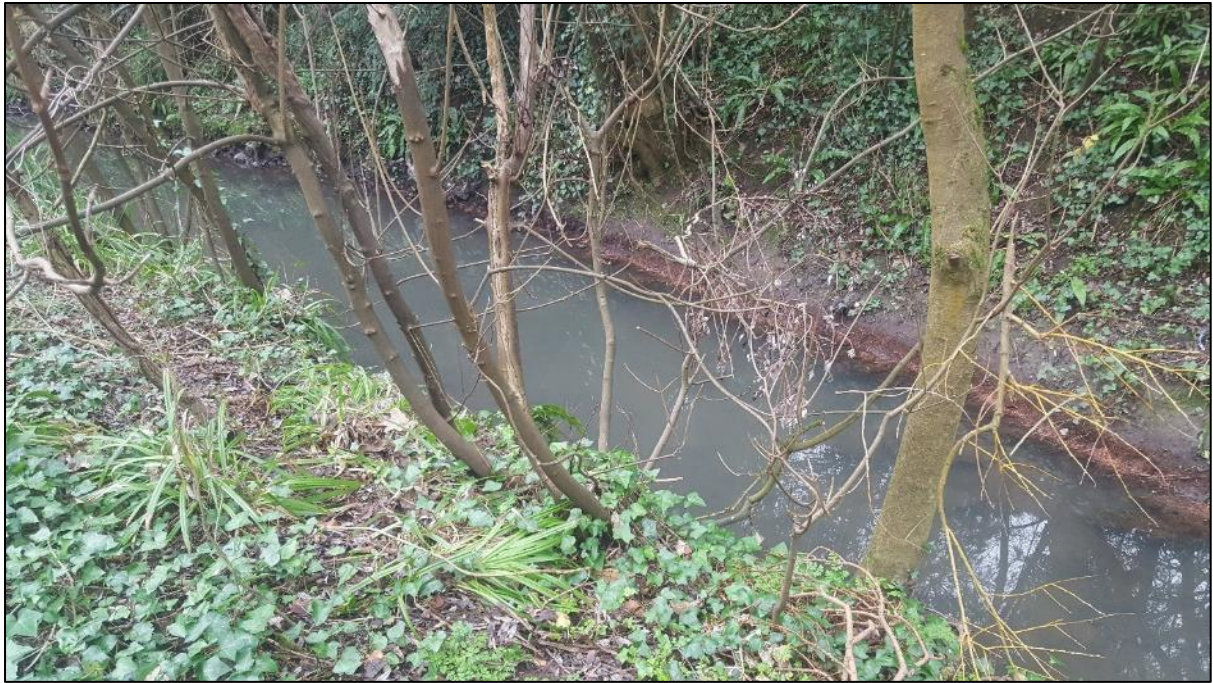
Figure 24: A cloudy, blueish grey colouration is suggestive of household misconnections

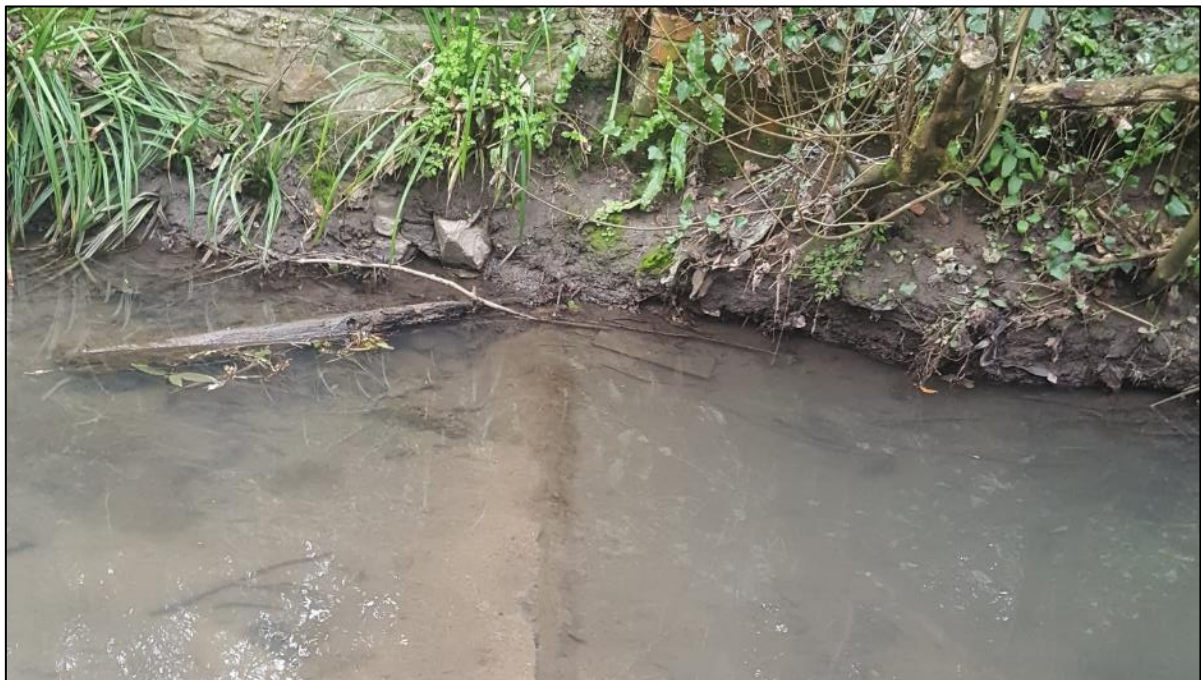
A small weir (possibly the remnants of an older and larger structure) was observed at the boundary of Blaise Castle House Museum on the RB (Figure 25). The structure was almost entirely buried in fine sediment and further investigation may be required to ascertain its purpose (if any) and condition. The structure is not a barrier to fish passage but is nonetheless an interruption to sediment transport and impounds the river, contributing to the excessive silt deposition

Figure 25: a weir (or the remains of one) is submerged but still impacts on habitat quality

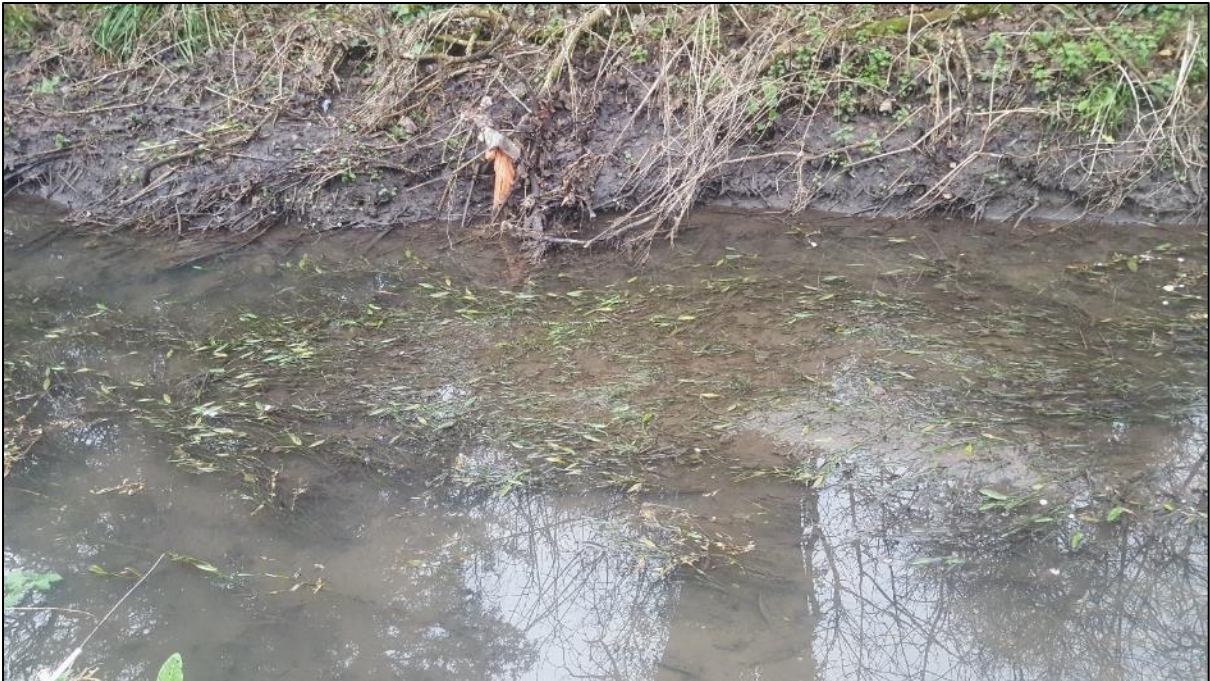
Patches of pondweed (*Potamogeton* sp.) were observed nearby emerging from thick silt (Figure 26). As the name suggests, this is a species that favours slack flow conditions. It's presence in a stream is indicative of abnormally (and consistently) sluggish flows.

Figure 26: Pond weed in a river is indicative of abnormally sluggish flows

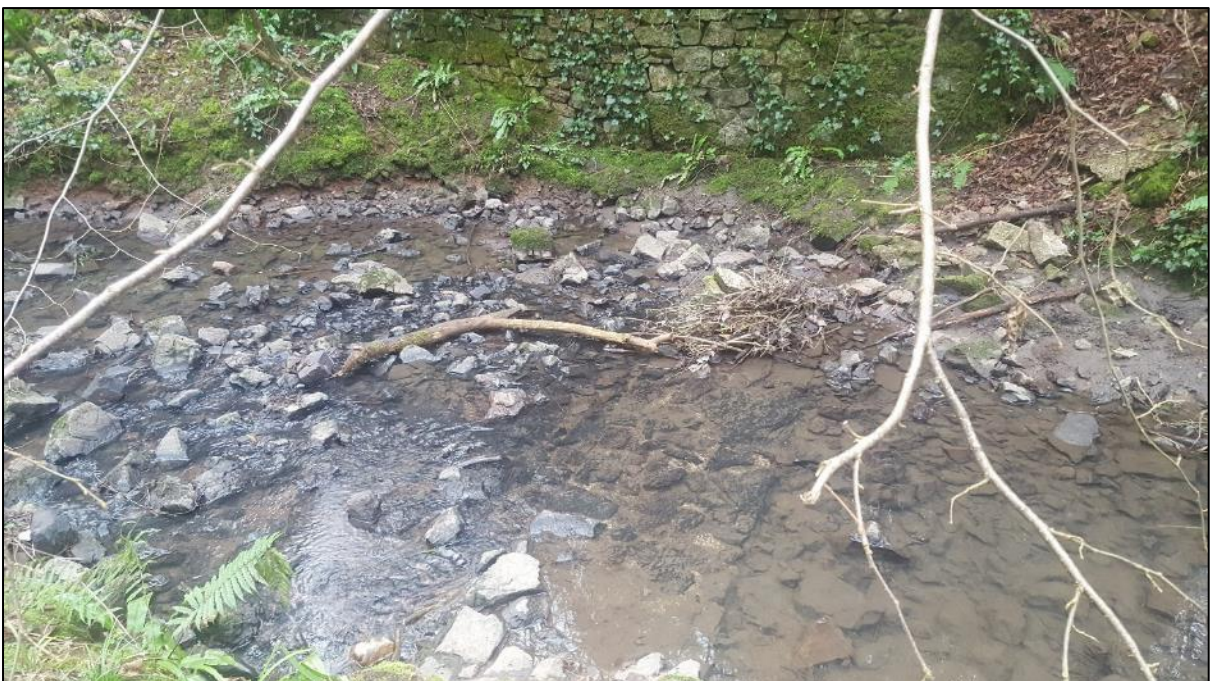
A little further downstream the remnants of another weir were observed. The structure has been almost entirely demolished but the footings are still present in the bed (Figure 27). It also delineates a significant change in the character of the brook. Above, the brook is sluggish and silty but below it is shallow and free flowing with very little fine sediment.

Figure 27: The remnants of another weir interrupt natural sediment transport and impact on habitat diversity

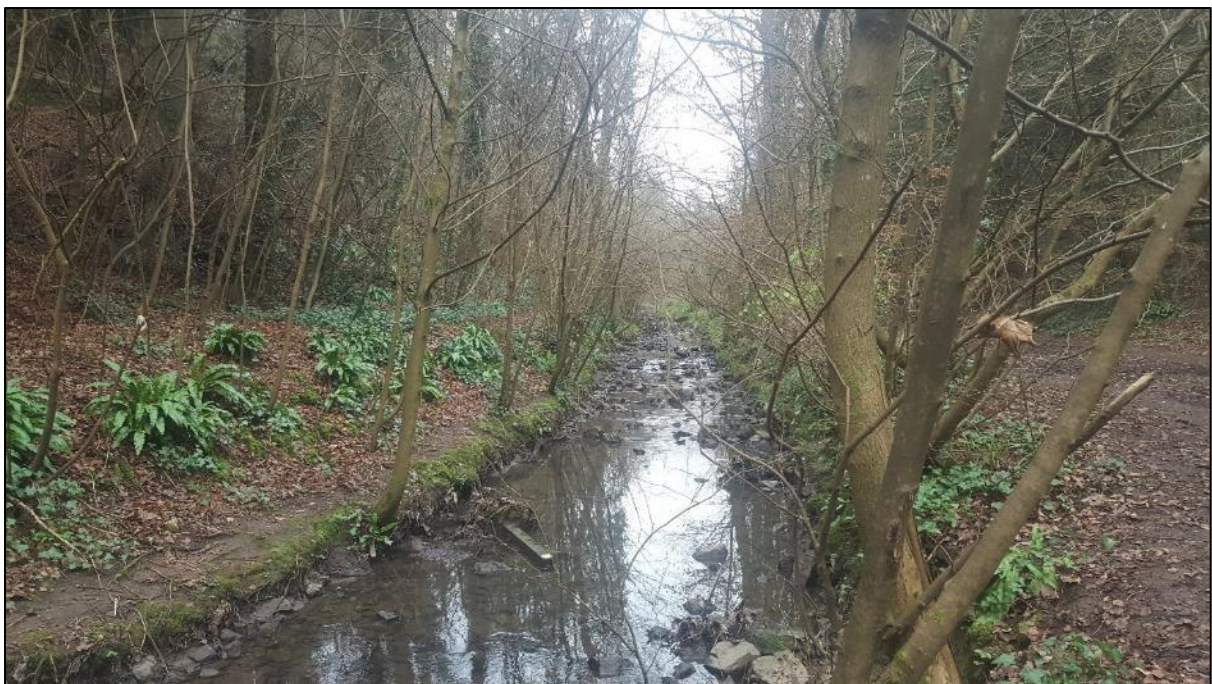
Figure 28: The channel is straight and steep, lacking in habitat diversity through the upper gorge

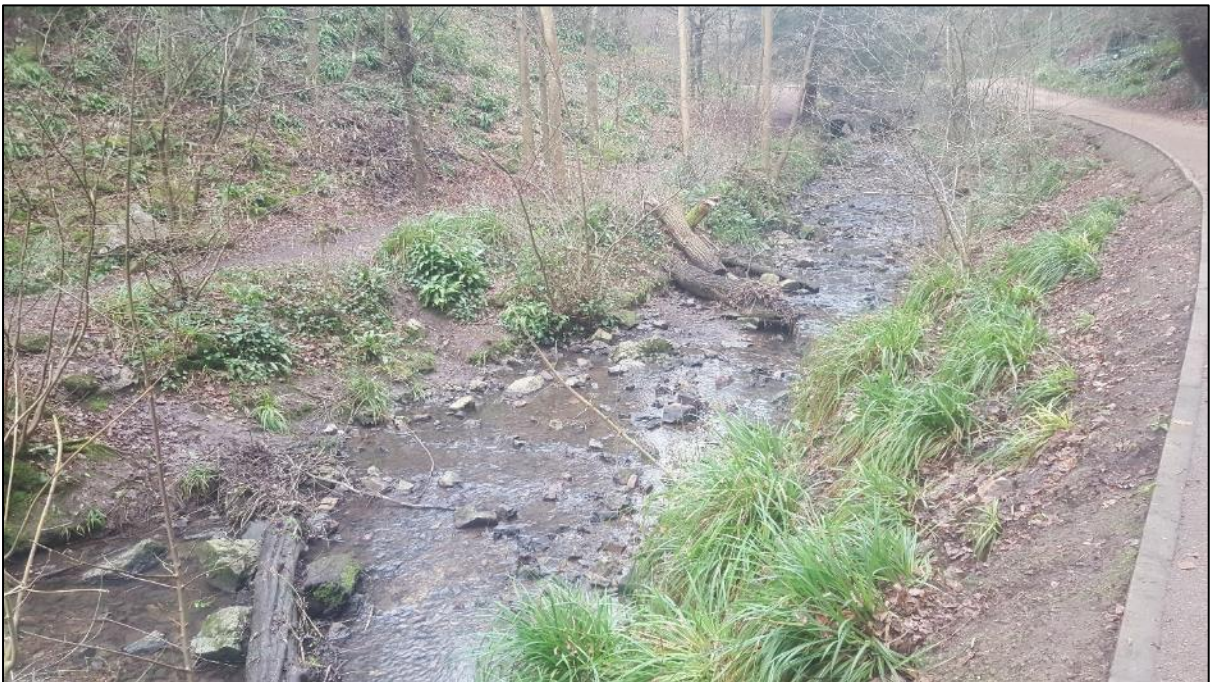
Downstream of the mill, the brook is afforded a little more space and the banks are populated with sedges and small saplings. Natural woody debris in the channel helps to diversify flow patterns and promote the formation of small gravel bars, and any urges to remove these and 'tidy up' the channel should be resisted (Figure 30). The steep scree slopes (Figure 31), particularly on the RB are a natural source of stones and gravel which help to drive a degree of natural geomorphology despite the interruptions to sediment transport upstream.

Figure 30: Woody material in the channel helps to diversify habitat

There are many opportunities to introduce some additional woody habitat features into the channel, helping to increase friction and further improve habitat diversity. For example, laying some of the bankside hazel stems down along the channel margins (in a fashion similar to hedge laying), could provide good habitat for marginal plants and aquatic invertebrates. Were habitat connectivity better, such features would also provide excellent cover for fish. Unfortunately, a series of barriers fragment the brook and act as complete barriers to fish passage. The first barrier downstream consists of a long concrete basin above a tall block stone weir (Figure 32).

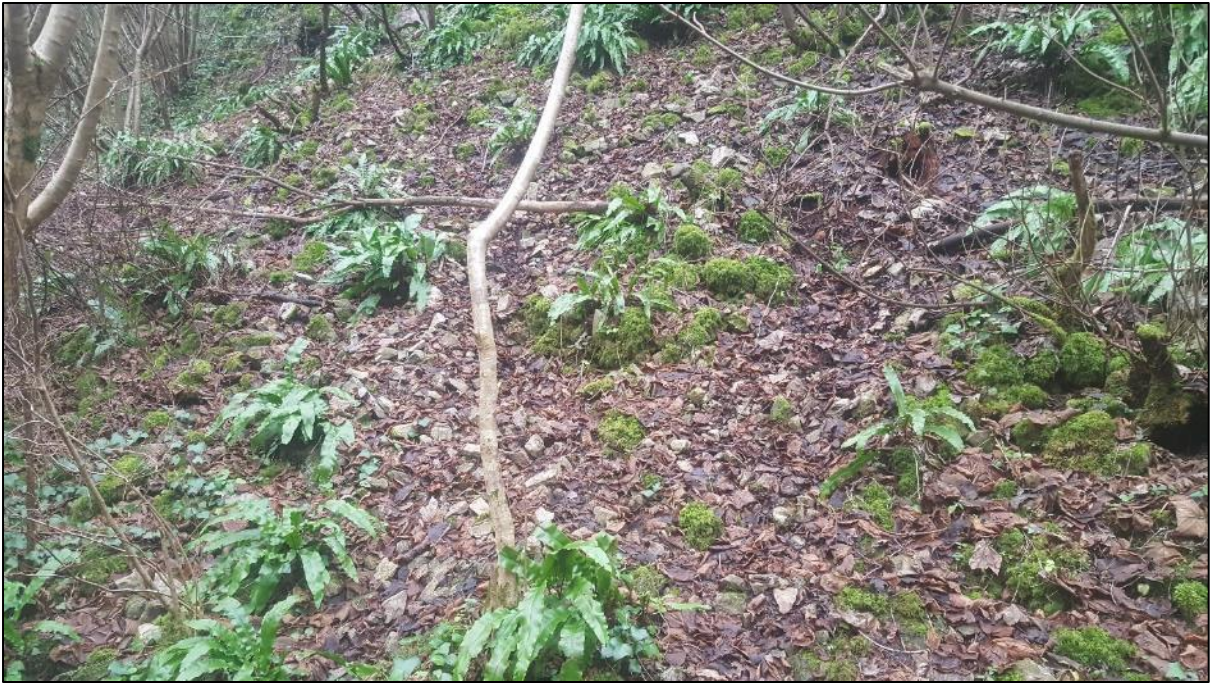
Figure 31: The natural scree slopes provide a regular supply of gravel into the river system
