River Trym and Hazel Brook, North Bristol

Wild Trout Trust report following an Advisory Visit, January 2019

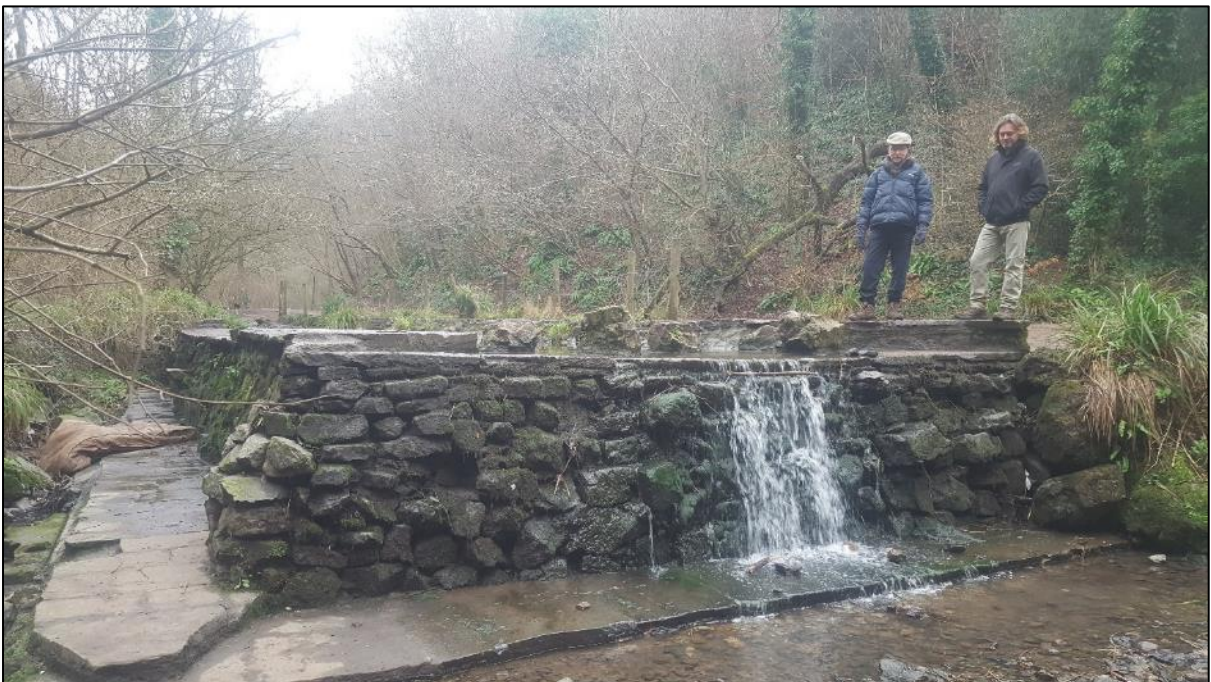
Figure 32: A large weir, part of the historic landscaping work, fragments habitat for fish and invertebrates

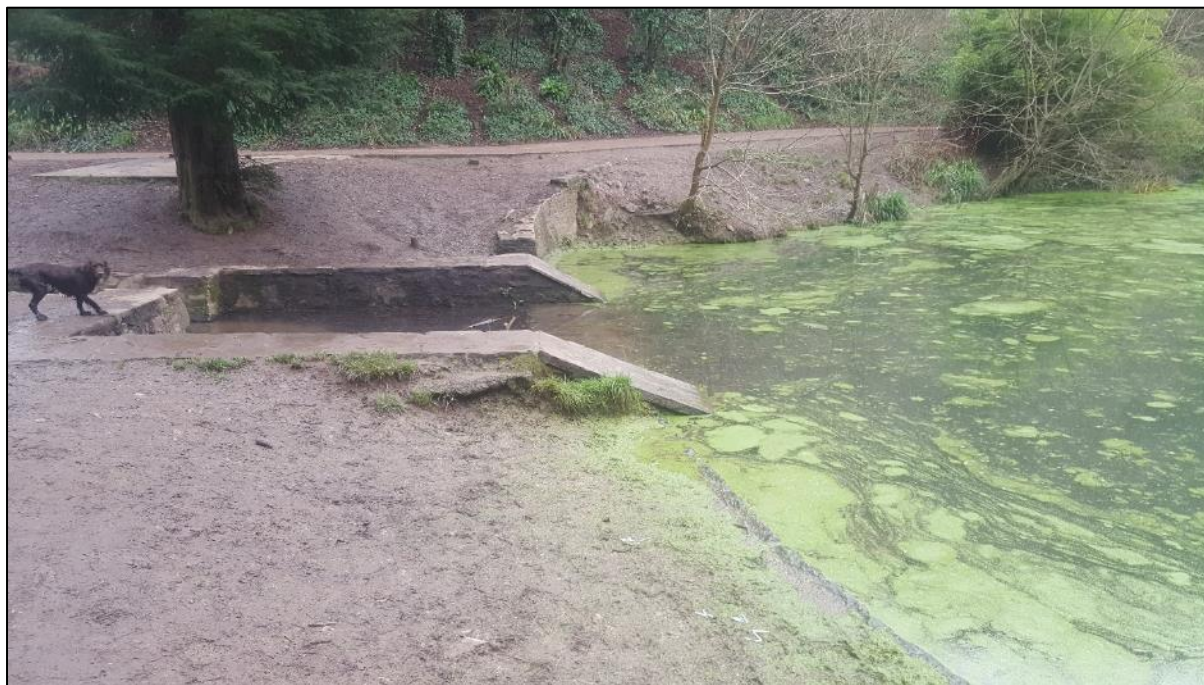
Figure 33: The small sediment trap is not enough to prevent sediment and pollutants accumulating in the pond.

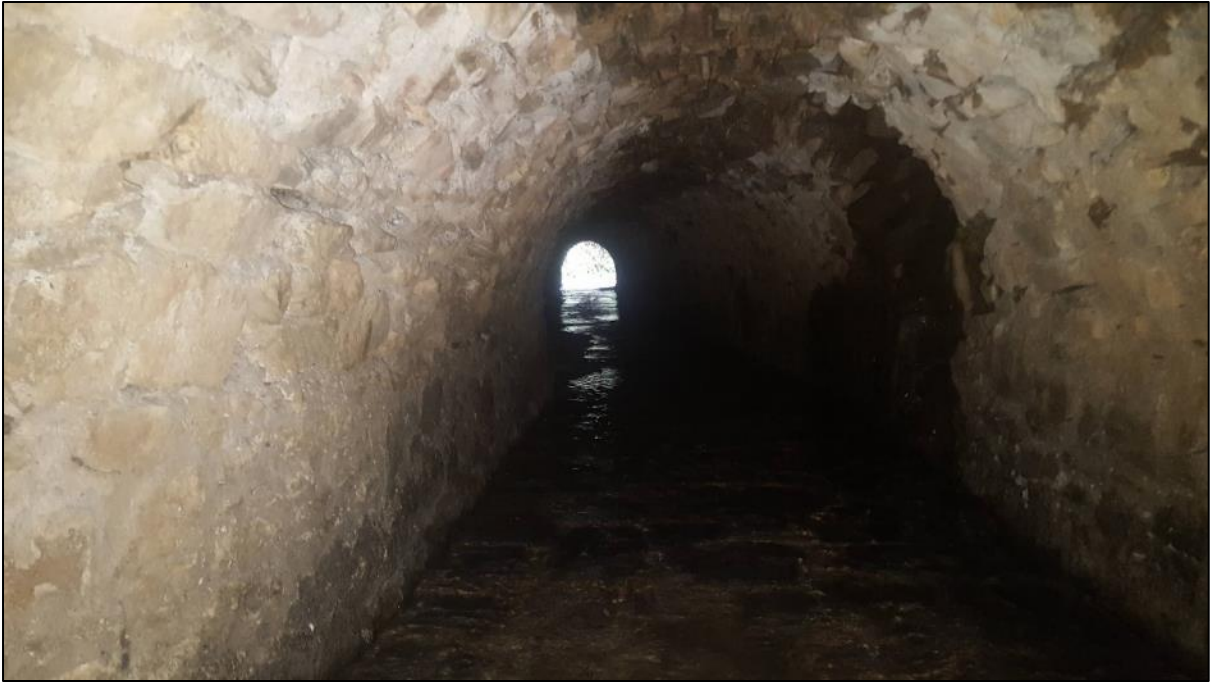
Figure 34: The culvert under the path around the pond is flat-bottomed and a barrier to fish passage

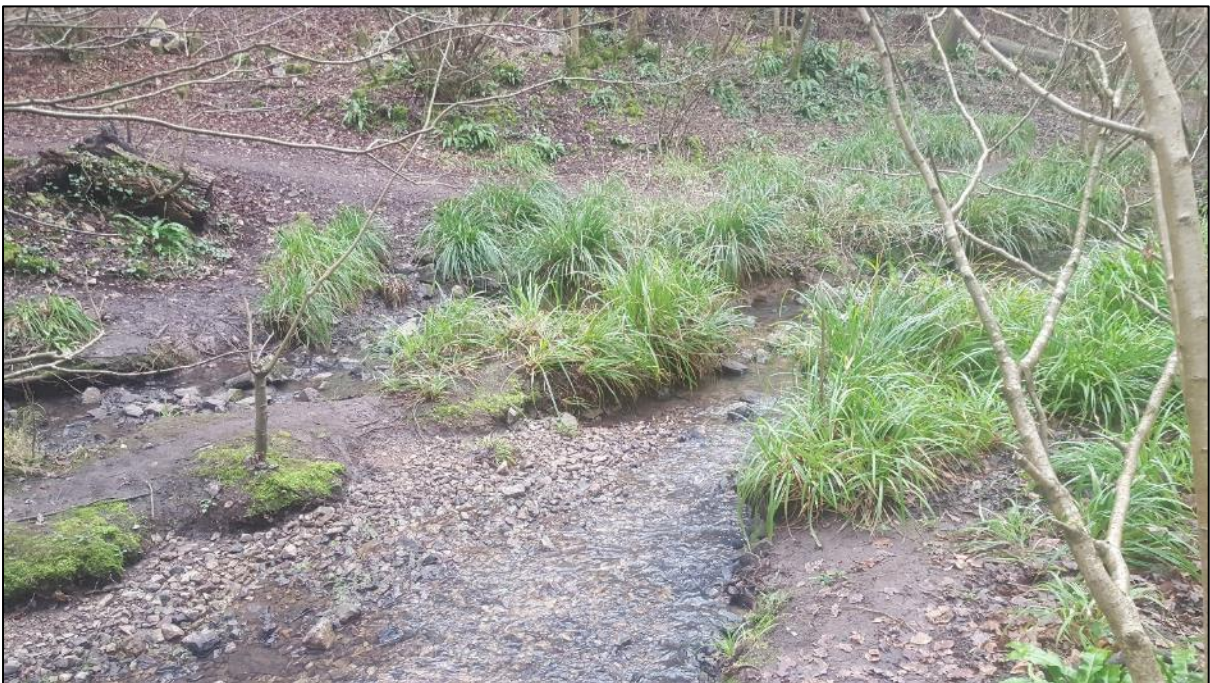
The component of the brook which is not diverted through the pond is directed around it in a flow-depleted but otherwise natural channel which then becomes culverted under the path around the pond (Figure 34). This culvert is flat-bottomed and is a barrier to fish passage. Below the culvert, the outflow from the pond re-joins the brook and the valley floor broadens out, becoming densely wooded. Geomorphology improves as the gentler gradient is combined with a greater diversity of sediment sizes (including small-medium gravels) and occasional natural woody features (Figure 35).

Figure 35: Some natural morphology resumes below the pond

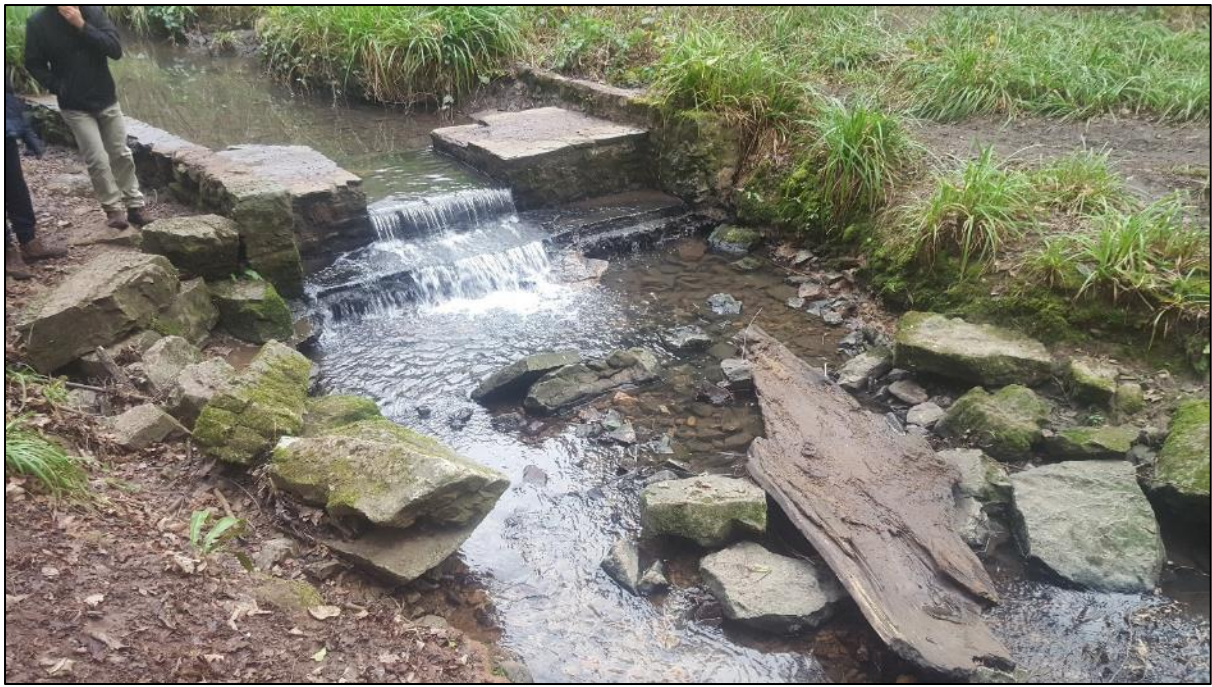
Figure 36: Another weir, presumably constructed to divert flow into the adjacent pond

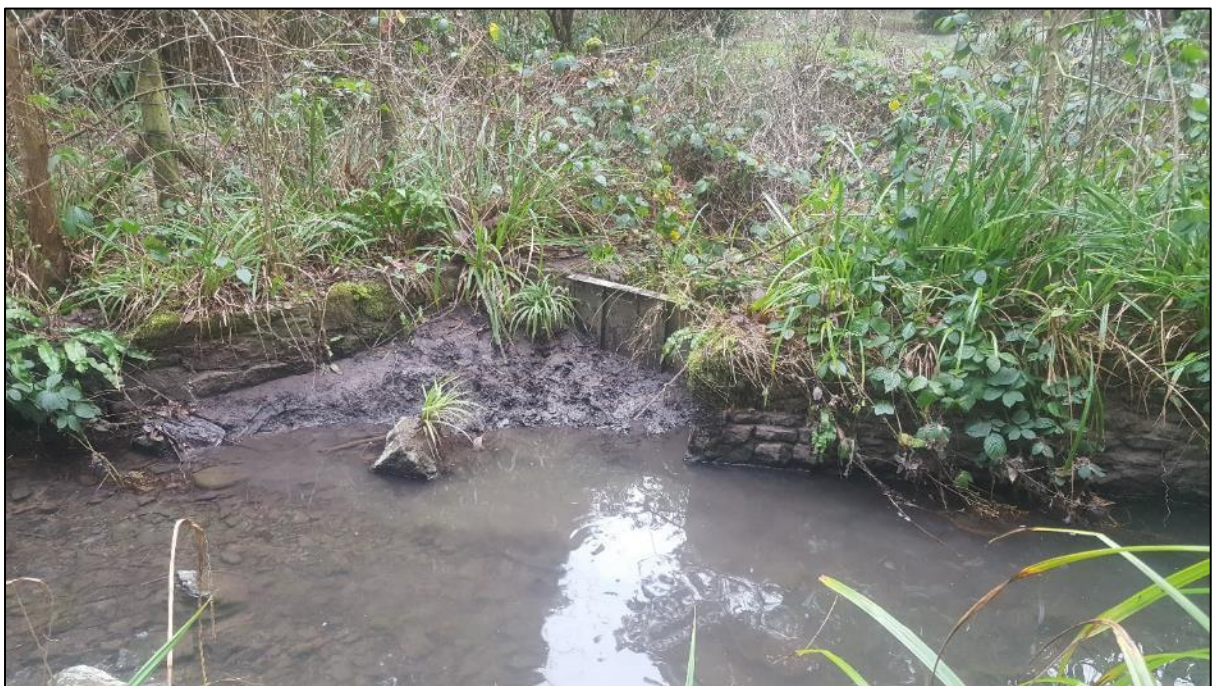
Figure 37: The offtake for the pond is silted up and the pond is offline, suggesting the weir could be removed.

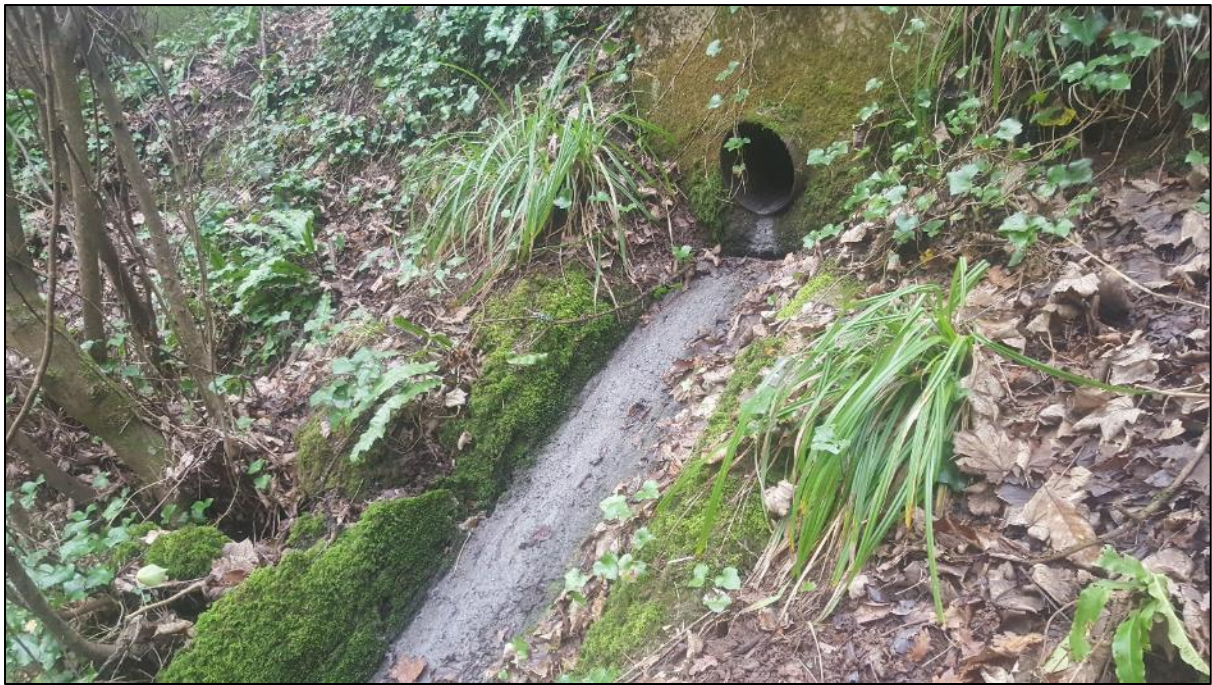
Figure 38: Sewage fungus stains the outfall, suggesting misconnected foul water

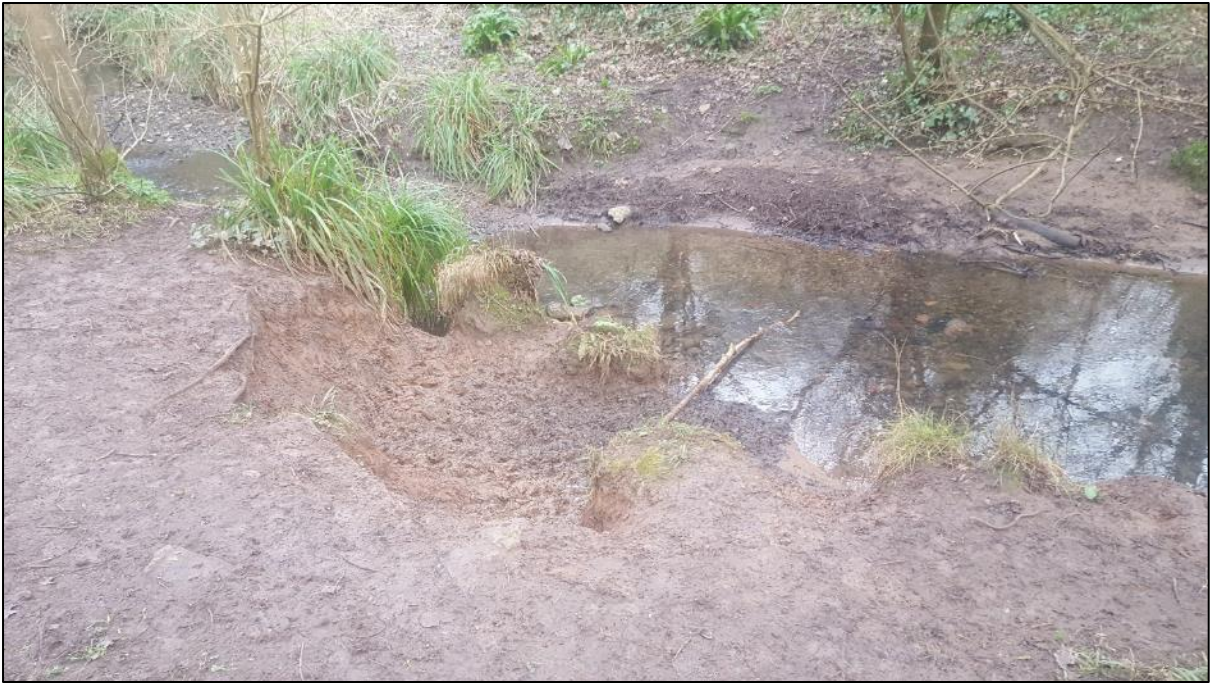
Downstream of the pond, the brook exhibits some good quality habitat with a high diversity of coarse sediments, natural woody features and overhanging bankside vegetation. However, some dog slides (sections of acute bank erosion caused by dogs scrambling in and out of the river) are bare of cover and function as point-sources of fine sediment (Figure 39).

Figure 39: Severe bank erosion where dogs access the stream

Excluding dogs from streams in popular, publicly accessible places is extremely difficult and it may sometimes be more practical to formalise such sites to facilitate dog access whilst also protecting the riverbank from further erosion. Examples of such works are outlined in the *Recommendations* section.

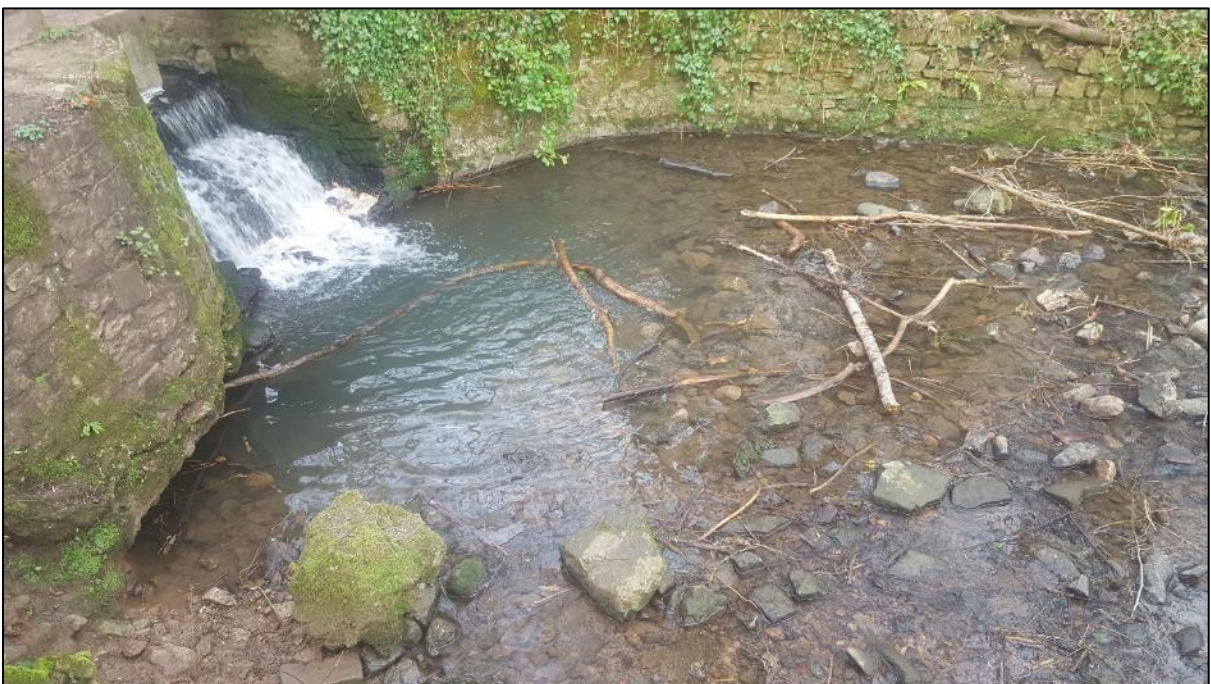
Near its confluence with the Trym, the Hazel Brook flows over another weir (Figure 40). This is most likely a redundant structure which once diverted flow through a leat to Combe Mill (long since demolished). The abutments of the weir are in a state of disrepair and threaten the structural integrity of the footbridge above. These will need repairing soon and presents an excellent opportunity to improve fish passage and sediment transport between the Hazel brook and Trym. The best ecological outcome would be the removal of the structure, replacing it with a clear span footbridge.

Figure 40: The weir at the confluence of the Hazel Brook and River Trym

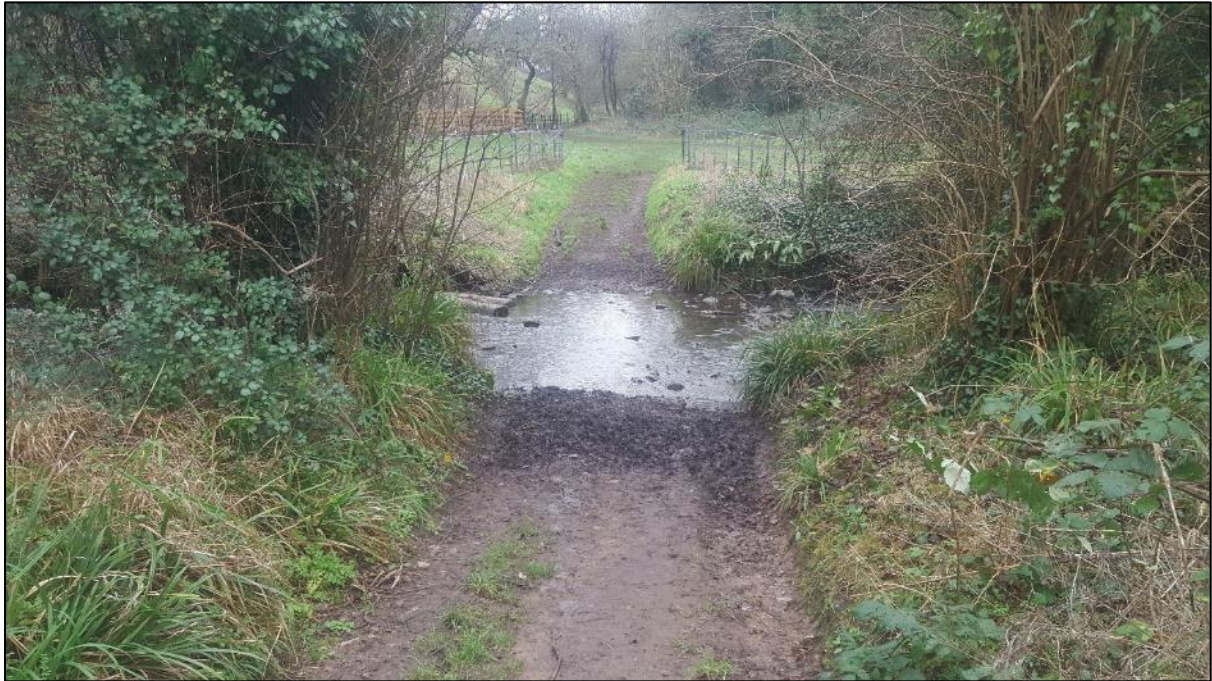
Supplemented with flow from the Hazel brook, the Trym starts to exhibit a greater diversity of depths and potential habitat for adult trout or other flow-loving fish species. As it flows out from the narrow gorge into a broad floodplain of the lower Blaise Castle Estate, footfall is less concentrated and so path and bank erosion are less severe. One potential point-source of excess sediment is the ford at ST558775 (Figure 41). This could be mitigated by the instatement of a crushed limestone hard-standing on the slopes of the ford.

Figure 41: The ford across the Trym at the downstream end of the Blaise Castle Estate

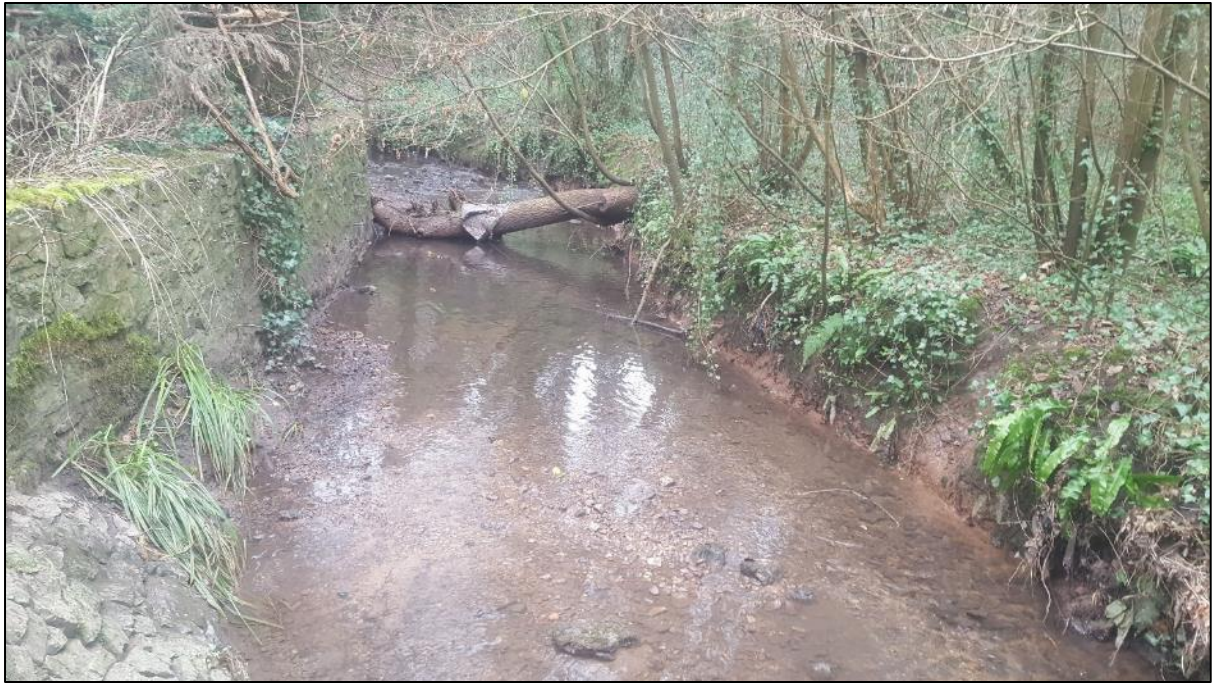
Toward the Combe Dingle car park at the downstream extent of the estate, a section of the LB is reinforced by a tall, block-stone revetment. It was most-likely associated with some aspect of Combe Mill and is near the point where the tail race (no longer present) from the mill would have re-joined the Trym. This limits marginal cover habitat and so any instances of low-hanging branches or trailing vegetation (such as ivy, sedge or ferns) should be retained (Figure 42). Naturally fallen woody features should also be retained wherever possible. Although depth variation is greater than upstream, the river still lacks well-defined deep pool habitat. Large, woody features can deflect flow into the riverbed, scouring deep pools and cleaning the riverbed of fine sediment. It is worth noting that in urban catchments, such features can also intercept litter and become unsightly. However, such 'litter traps' can be useful hotspots for organised river litter picks.

Figure 42: Trailing vegetation and woody debris helps mitigate the impact of hard-engineered bank revetment

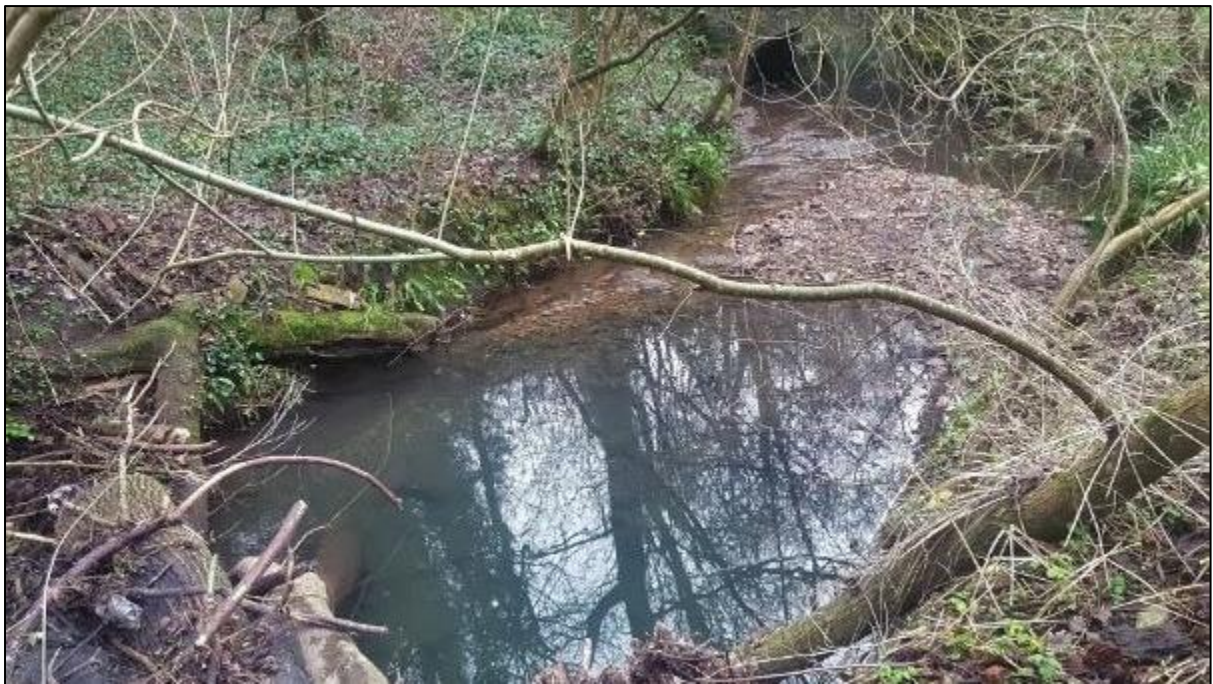
Figure 43: How pools and riffles form: the accumulation of wood on the left of this photo has created powerful undershot scour, forcing the river to dig down into the bed and throw up the large gravel riffle downstream.

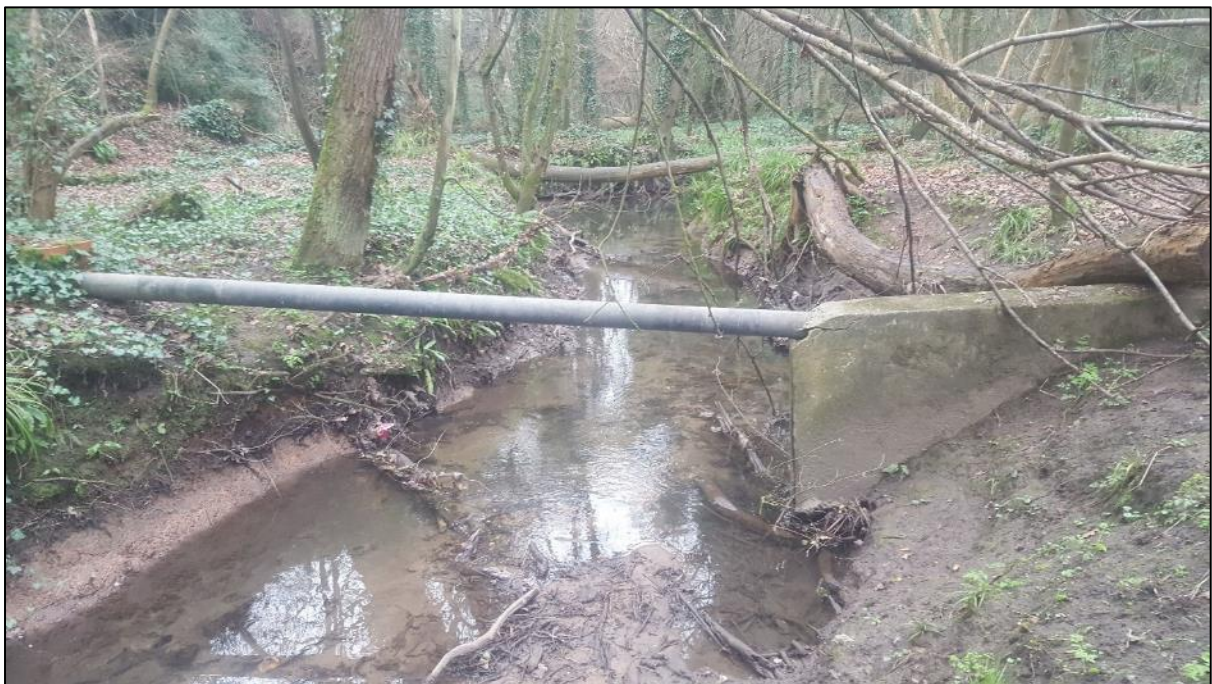
Proceeding downstream through the valley, the river becomes increasingly uniform in profile, flowing between incised clay banks. This uniformity is possibly due to historic dredging to protect the sewer line that runs parallel to the river. However, repeated scouring by urban-runoff peak flows and lack of flow-deflecting woody material will also play a role. The character of the riverbed changes significantly; from gravelly, to smothered in silt. This may be further evidence of dredging, suggesting that either gravel has been removed, or the gradient of the bed has become abruptly shallower. It should also be noted that as the Trym flows down from the scree-strewn karst gorges and onto the alluvial floodplain below, the supply of gravel from the riverbanks is reduced. In a natural river this wouldn't be a problem as gravels should be continuously transported down from the headwaters. However, when natural sediment transport is interrupted by weirs (repeatedly on both the Trym and Hazel Brook), the lower river will experience a net loss of gravel, resulting in bed incision and increased habitat uniformity. The result is a channel lacking the natural variation in width and depth required to support a healthily functioning river ecosystem.

Figure 44: The character of the river changes as it progresses downstream.

The floodplain between The Dingle and Dingle Road would benefit from a programme of woodland management to improve light conditions, promote a more diverse understory, and improve biodiversity. Specifically, this would allow more

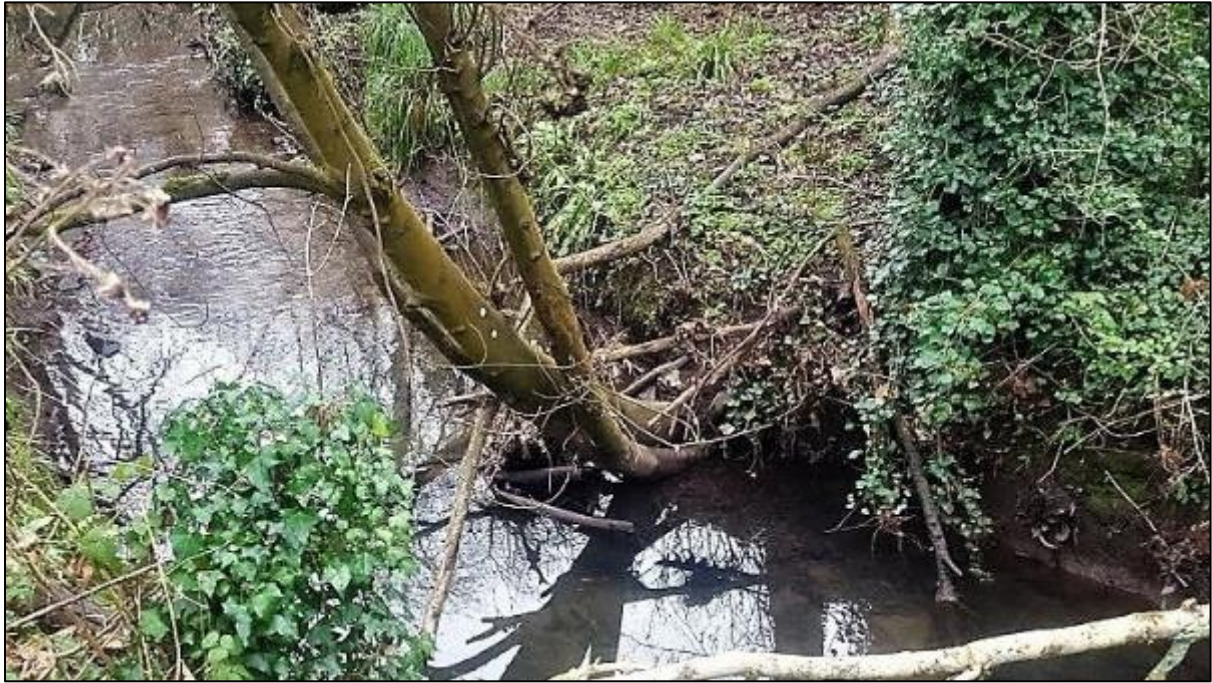
Very few fish were observed. However, a nice shoal of roach (*Rutilus rutilus*) and rudd (*Scardinius erythrophthalmus*) was found downstream of Dingle Road. A heavily-leaning sycamore was protruding into the flow, scouring a small pool surrounded by and roots and other woody material, creating a small oasis of diverse habitat features (Figure 45). At least one trout has apparently been seen in this area.

Figure 45: An area of complex structure, in an otherwise featureless stretch of channel, provides a pocket of habitat for fish.

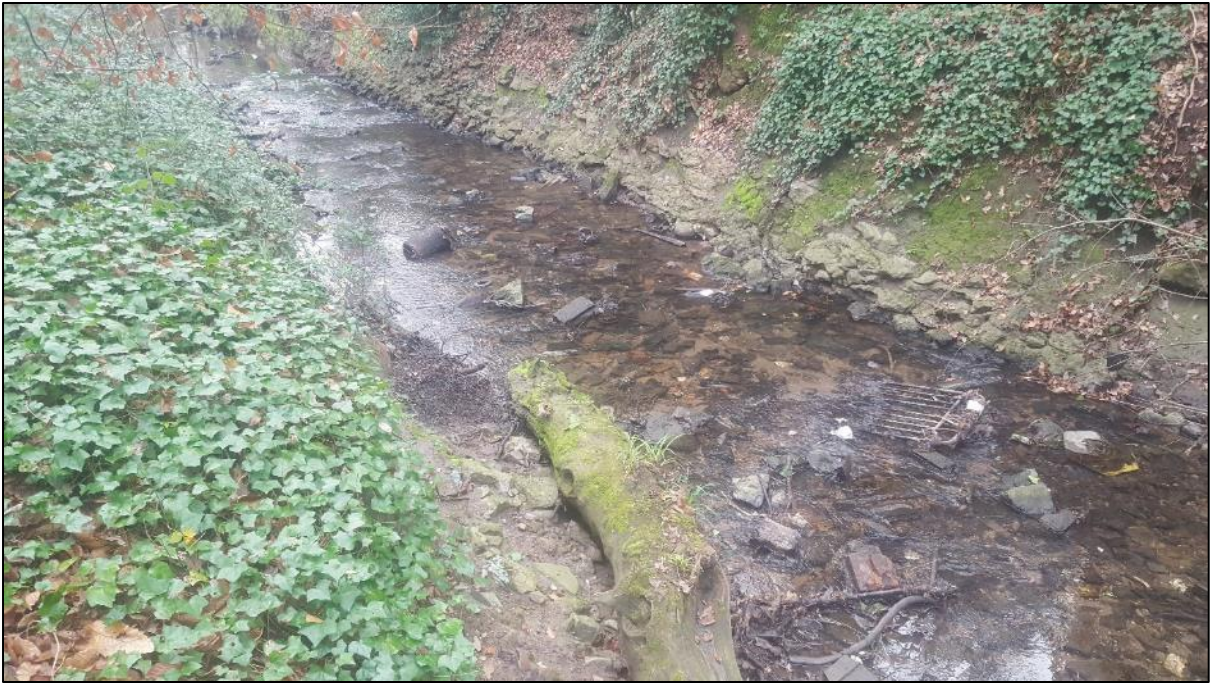
As the river flows through the narrow woodland parallel to Combe Bridge Avenue, the riverbed becomes less silty and is instead strewn with larger stones (Figure 46). Some appear to be natural, but many are engineered blocks and bricks. There is a high volume of litter and other urban detritus, but also a few valuable woody features. This is a good reach for organised river clean-ups but care should be taken to ensure that valuable habitat features (such as fallen wood) is retained in-channel.

Figure 46: River clean-ups should focus on removing human-made materials, leaving woody features in the river.

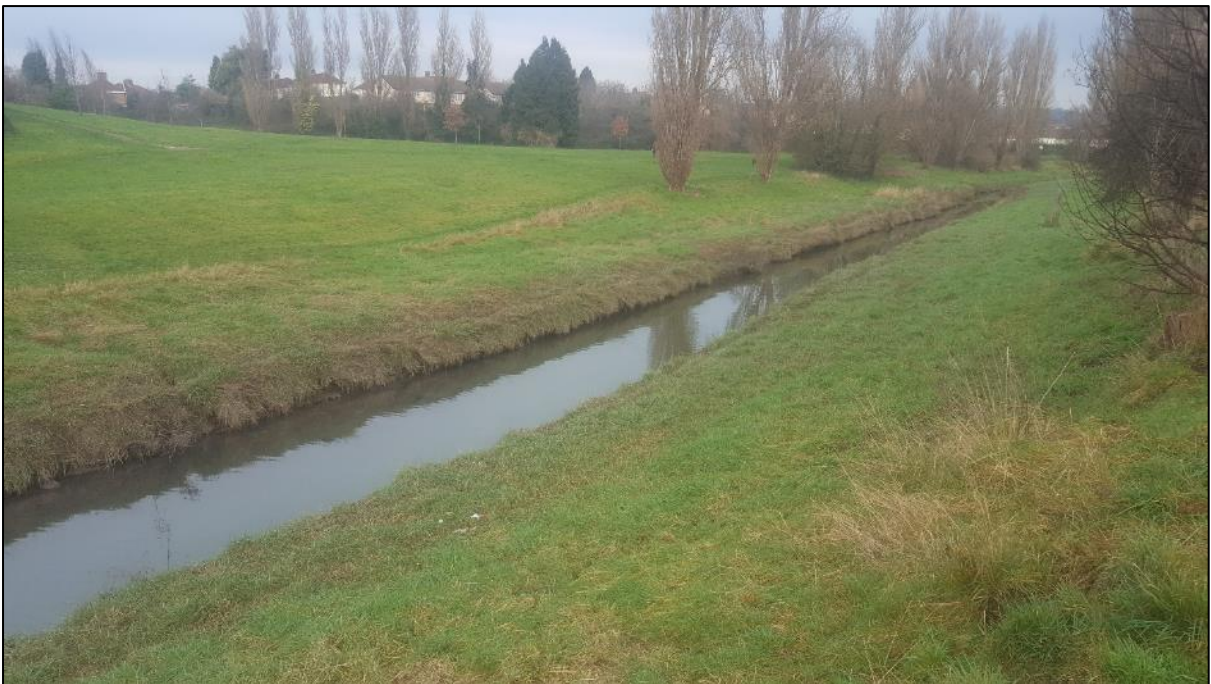
Figure 47: The lower reaches of the Trym are impounded by the weir at Sea Mills.

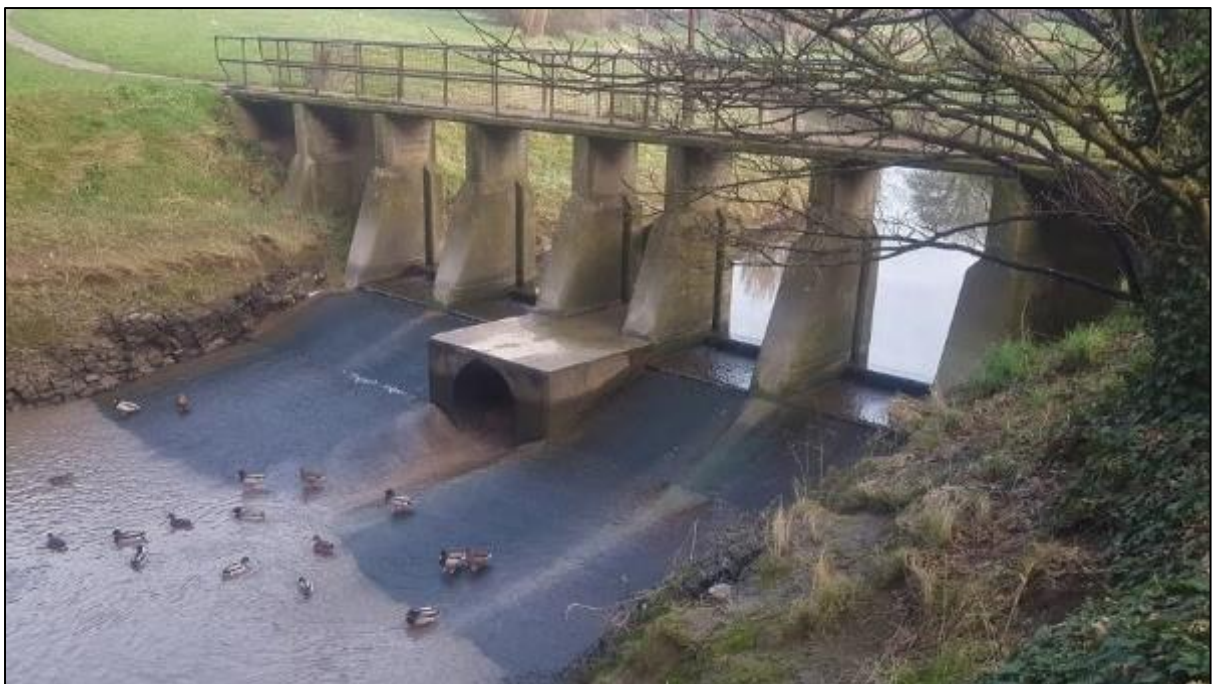
Figure 48: The weir and tidal sluice gates at Sea Mills

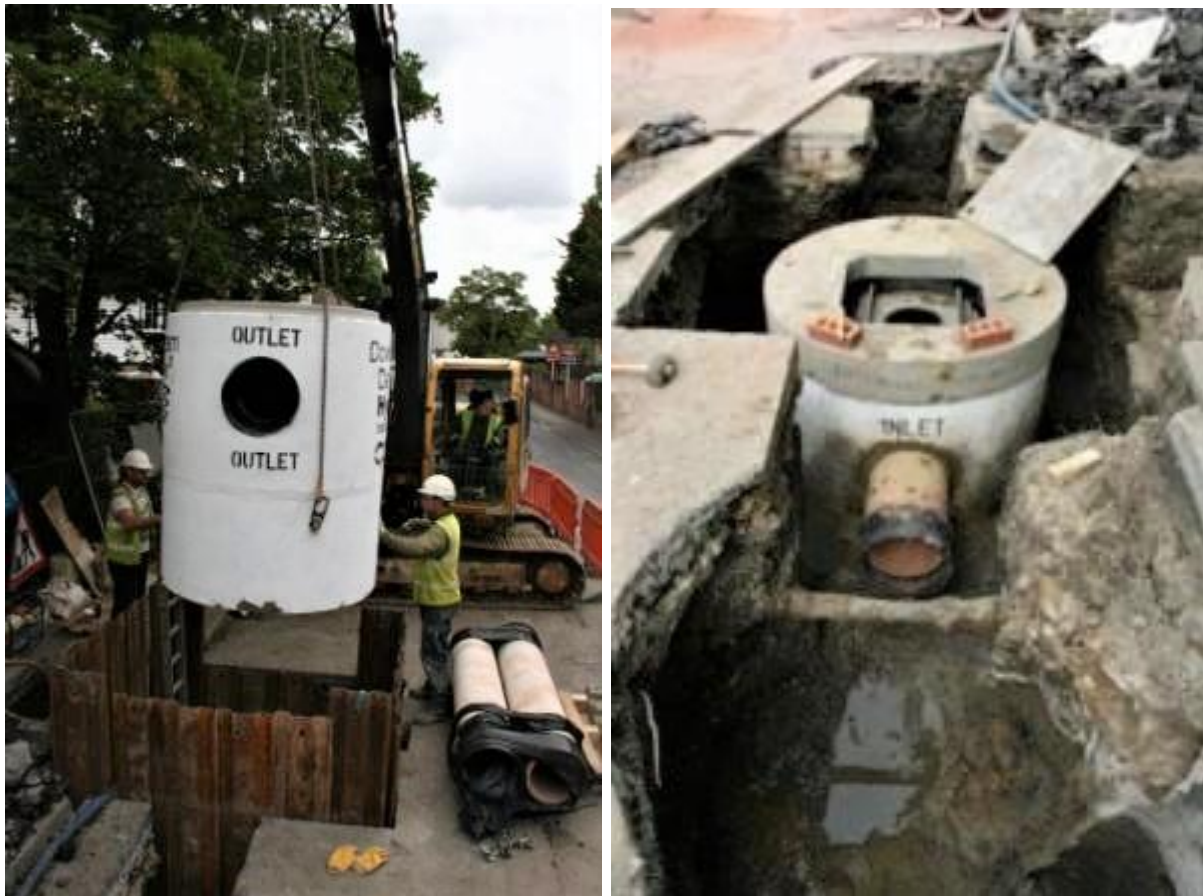
Figure 49: Downstream Defender hydrodynamic vortex chamber silt traps, originally designed for very high volumes of motorway runoff, being installed to intercept sediment in surface water drains in south London (Photo: South East Rivers Trust)

Other options to mitigate water quality problems include breaking out drainage pipes into reed beds, or even fitting specially-commissioned 'Downstream Defender' silt traps to intercept fine sediment from urban run-off (Figure 49).

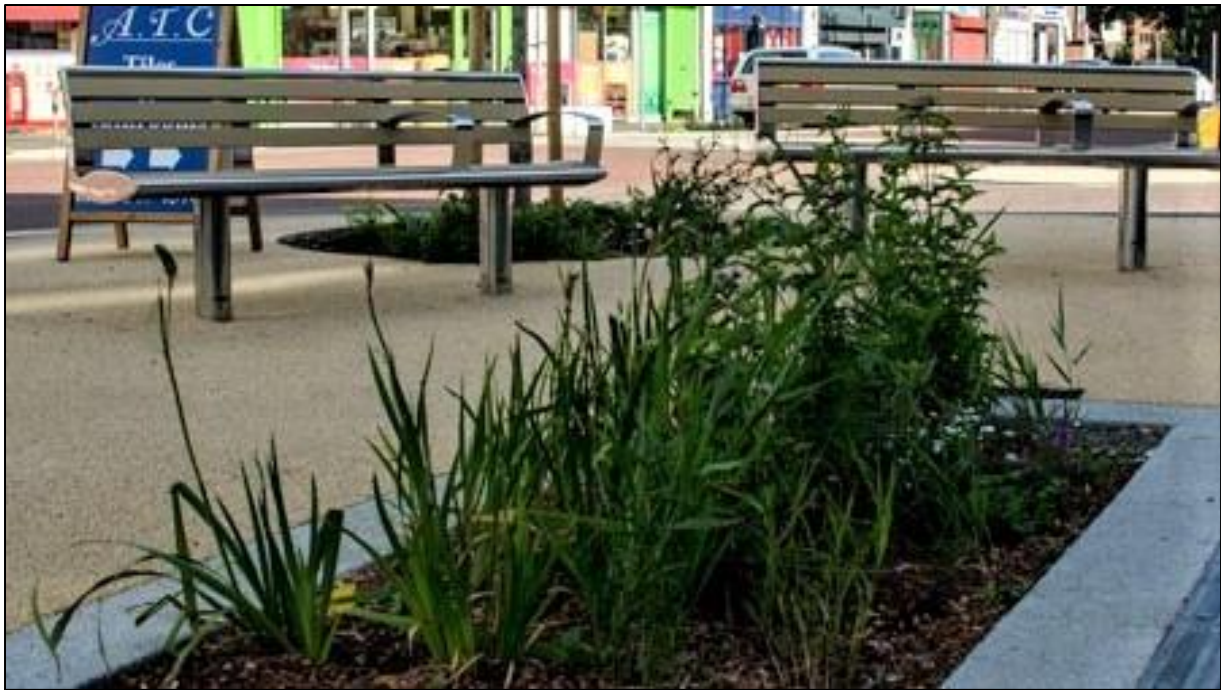
Figure 50: Rain gardens in south London have helped to attenuate urban runoff into the nearby River Wandle. Retrofitting these structures in the urban parts of the catchment could help to reduce scouring flows in the river (Photo: One Planet Sutton).

Sustainable Drainage Solutions (SuDS): engaging with local planning authorities to mandate permeable paving, rain gardens, swales and green roofs for all new developments will help to future-proof the catchment of the Trym from becoming even harder and 'flashier' in years to come (Figure 50). In the meantime, such interventions can often be retrofitted into urban areas when redevelopment takes place, or when local streetscapes are periodically upgraded.

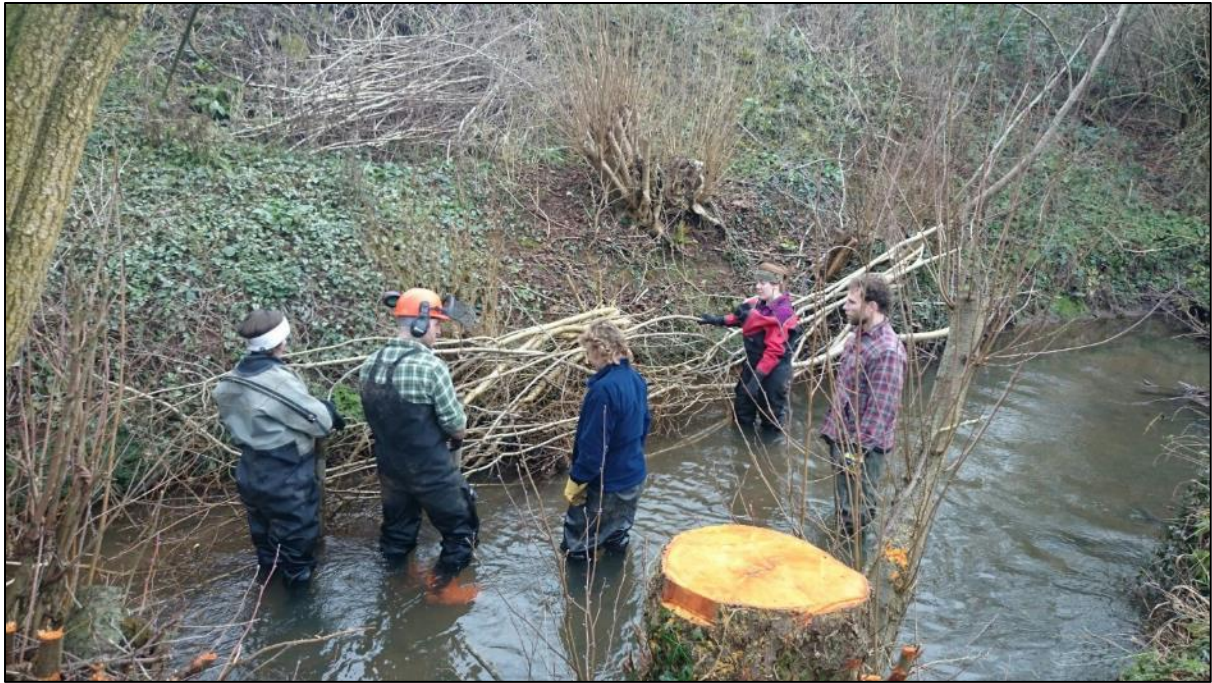
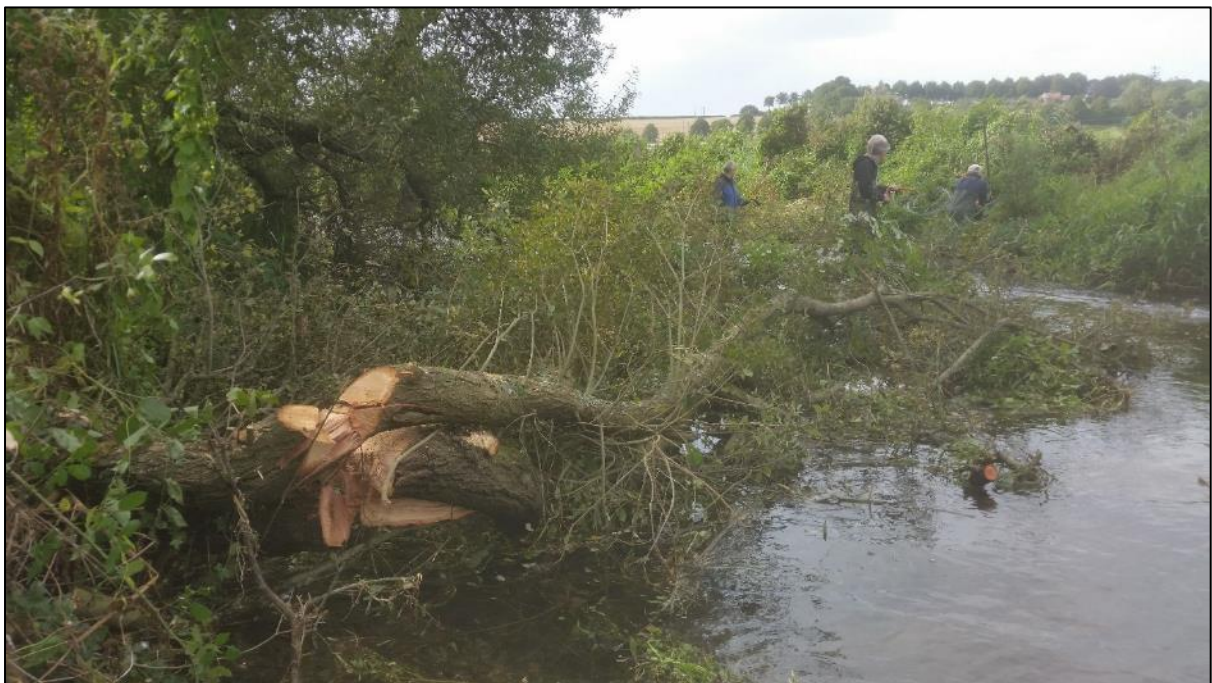
Figure 51: Bankside hazels 'hinged' into the channel margins to provide habitat on a Bristol Avon tributary

Figure 52: Bankside willows hinged into a river in Dorset

Introduced woody features provide the best habitat and function if they are kept in as natural a condition as possible. The goal should be to mimic the type of habitat that would be created when a tree naturally falls into the river. However, in urban catchments it is sometimes necessary to be a little more prescriptive. Securing small tree limbs or logs to the riverbed with wooden stakes (ideally sustainable, untreated sweet-chestnut) is a good way of ensuring such features do not increase flood risk. One of the most naturalistic ways of securing woody features is 'hinging'. This involves cutting partially through a tree or limb and laying into the river in a fashion similar to hedge laying. Bankside willows, hazel and younger alders are suitable for hinging (Figures 51 & 52).

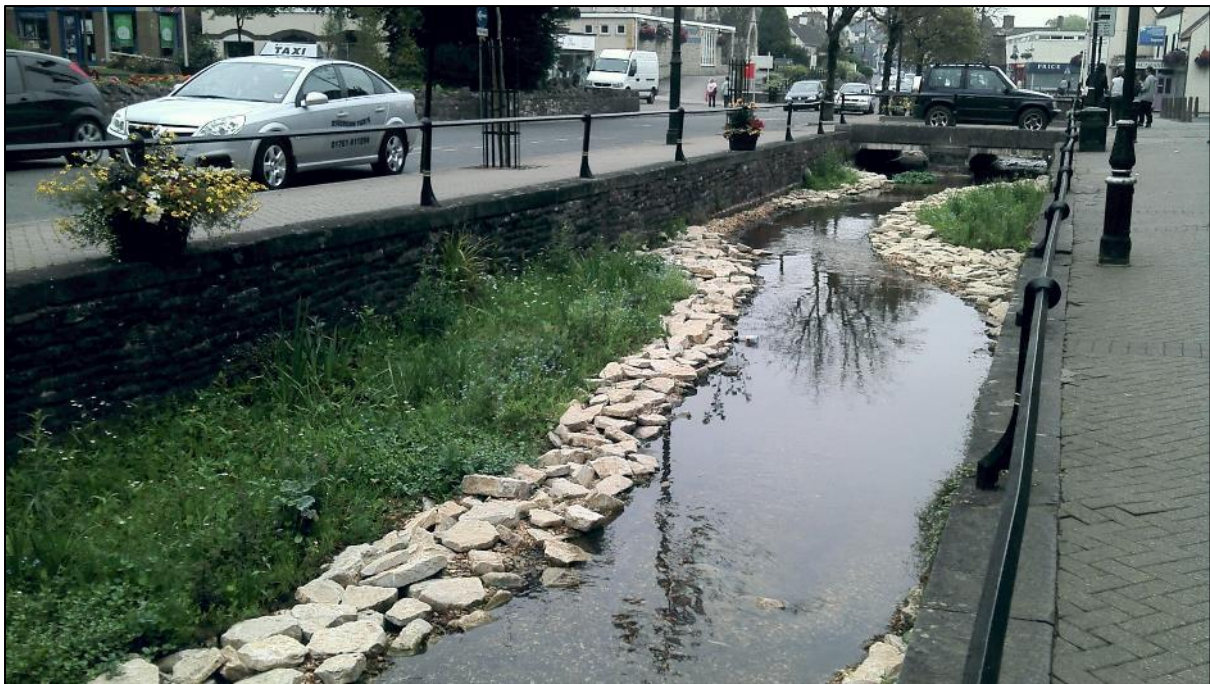
Figure 54: Backfilled and planted rock berms create a meandering channel for the River Somer in its armoured channel through Midsomer Norton, Somerset.

Suitable solutions could include reinstating a more sinuous flow path within the existing retaining walls by creating alternating berms to define a low-flow channel; see Figure 54.

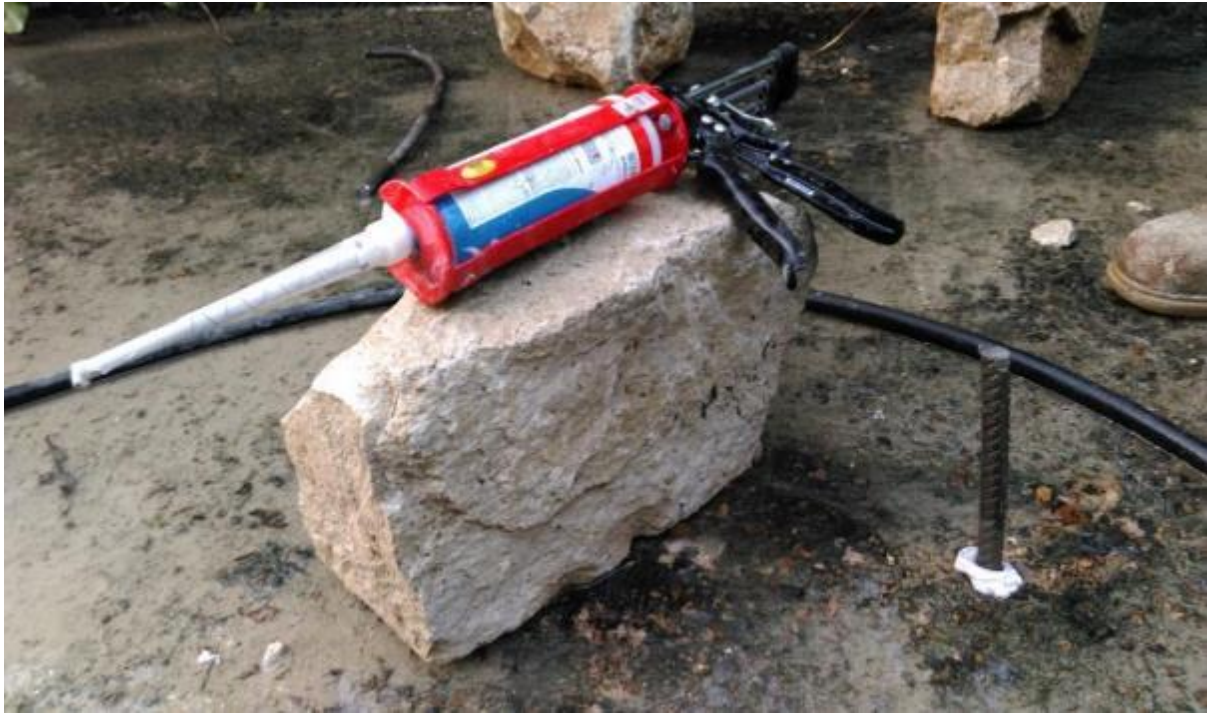
Figure 55: Resin, Purbeck stone and rebar: raw materials for adding roughness to the Hogsmill River in south London: see <https://www.southeastrivertrust.org/first-class-degree-in-fish-passage-at-kingston-uni/> for the full case study (Photo: SERT)

Alternatively, cobbles and small boulders of local limestone could be secured in place with steel rods or threaded bar chem-fixed with water-safe resin into pre-drilled holes in the stone and bed (Figures 55 & 56). These could then be used to retain introduced gravel, creating an artificial but naturalistic riverbed with a significantly broader diversity of habitat.
