River Trym and Hazel Brook, North Bristol

Wild Trout Trust report following an Advisory Visit, January 2019

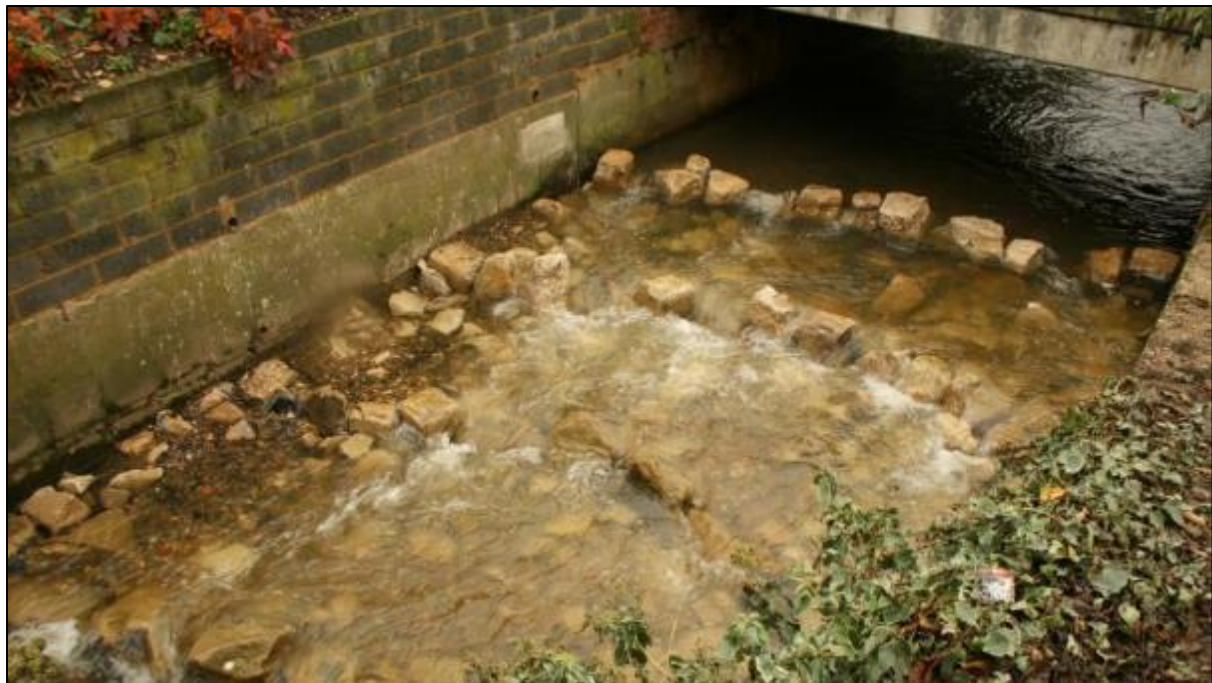
Figure 56: Introduced rocks and gravel create a range of habitats and flow dynamics in what was once a smooth concrete channel in the Hogsmill River (Photo: SERT)

Alternatively, cobbles and small boulders of local limestone could be secured in place with steel rods or threaded bar chem-fixed with water-safe resin into pre-drilled holes in the stone and bed (Figures 55 & 56). These could then be used to retain introduced gravel, creating an artificial but naturalistic riverbed with a significantly broader diversity of habitat.
